Conservation: Training, Reports (1966-1973): Article 05

SHELDON KECK and ROBERT L. FELLER

Detection of an Epoxy-Resin Coating on a Seventeenth-Century Painting

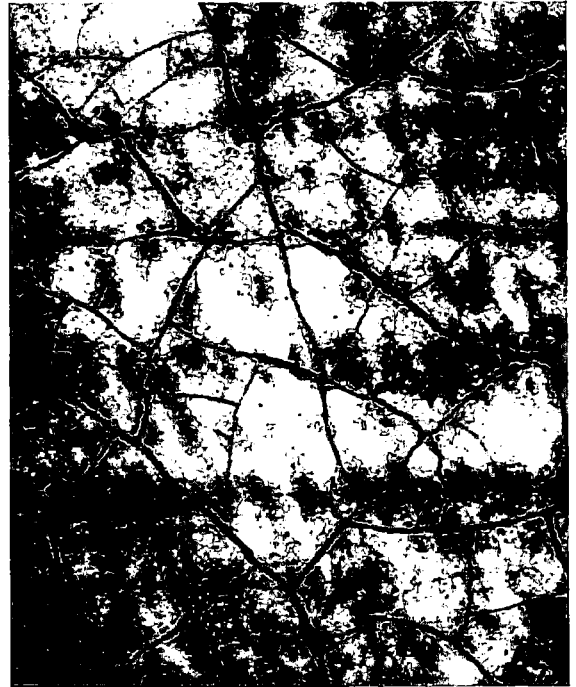
was not until the cracks on the surface were compared under low magnification with those in the radiograph that certain areas were found where the incised cracks did not precisely follow those in the painting beneath (Figs. 2A and B). (4) The original subject was probably extensively abraded, if one may judge from what was left of the unrepainted background. (5) A tough, insoluble protective coating had been placed over the repainting, apparently to prevent the readily-softened repaint from detection. On top of this coating had been placed a thin film of readily-soluble material.

FIG. 2B. *At left* photomicrograph $8\times$. Another area of paint with radiograph of same area *at right*. Crackle in surface of painting corresponding closely to that in radiograph shows variations and reinforcements which do not quite match the cracks themselves. Note particularly changes in upper left.
