Assessment of Damage and Adaptation Strategies for Structures and Infrastructure from Storm Surge and Sea Level Rise for a Coastal Community in Rhode Island, United States

Abstract: This paper presents an evaluation of inundation, erosion, and wave damage for a coastal community in Rhode Island, USA. A methodology called the Coastal Environmental Risk Index (CERI) was used that incorporates levels of inundation including sea level rise, wave heights using STWAVE, and detailed information about individual structures from an E911 database. This information was input into damage functions developed by the U.S. Army Corps of Engineers following Hurricane Sandy. Damage from erosion was evaluated separately from local published erosion rates. Using CERI, two different adaptation strategies were evaluated that included a combination of dune restoration, protective berms, and a tide gate. A total of 151 out of 708 structures were estimated to be protected from inundation and wave action by the combined measures. More importantly, the use of CERI allowed for the assessment of the impact of different adaptation strategies on both individual structures and an entire community in a Geographic

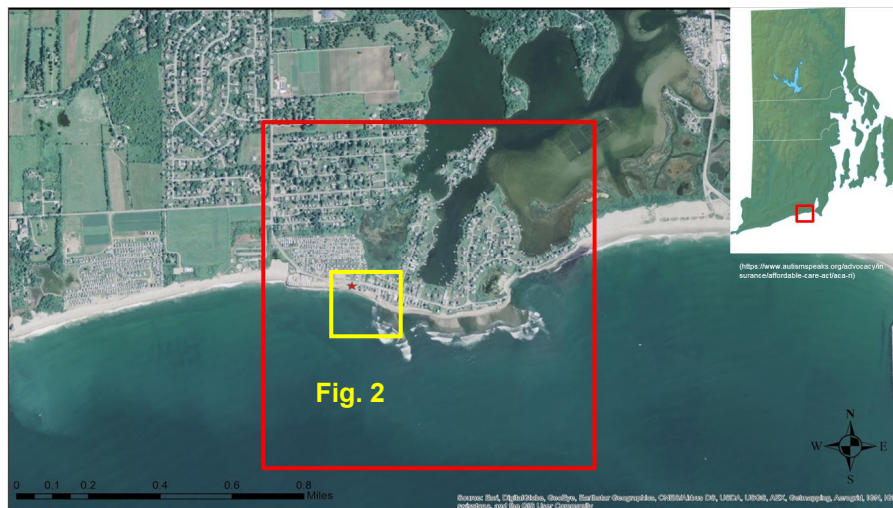
Figure 1. Site map of the coastal community of Matunuck, Rhode Island that was chosen for this study.

Matunuck, Rhode Island is a coastal community in the northeast United States that is vulnerable to the effects of storm surge, sea level rise, and erosion. As such, it is representative of many small communities that are facing these challenges without the resources of large urban cities. The Matunuck Beach community (Figure 1) has only one evacuation route, which is a coastal road that runs parallel to the shore and is highly susceptible to flooding. Erosion rates in this area are among the highest in Rhode Island [1], ranging from 0.8 to 3.5 ft/year (Figure 2). Figure 3 shows photographs of a local restaurant in the study area taken in the 1950s and 2012, clearly showing the loss of shoreline [2]. The evacuation route for the community can be seen in Figures 1 and 2 directly behind the restaurant.

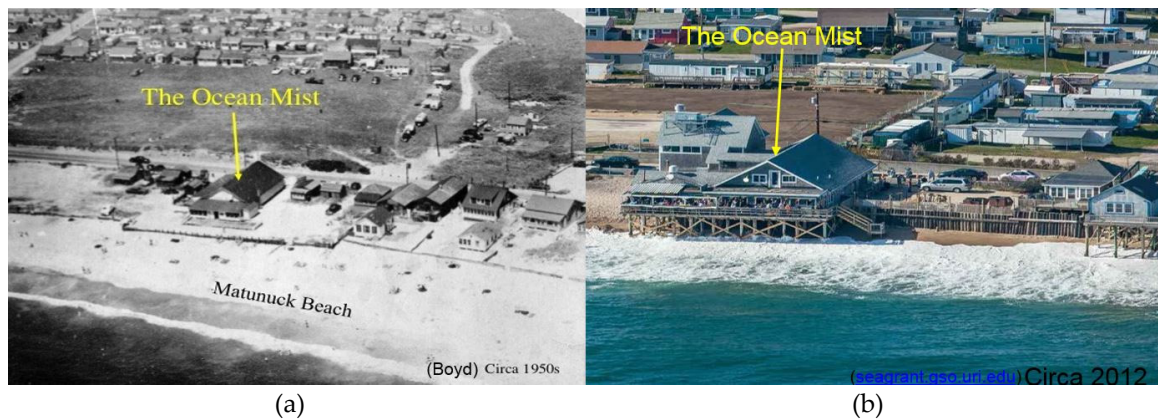
Figure 3. Photographs of a local restaurant in the study area from: (a) the 1950s; and (b) 2012, showing the loss of shoreline due to erosion [2].

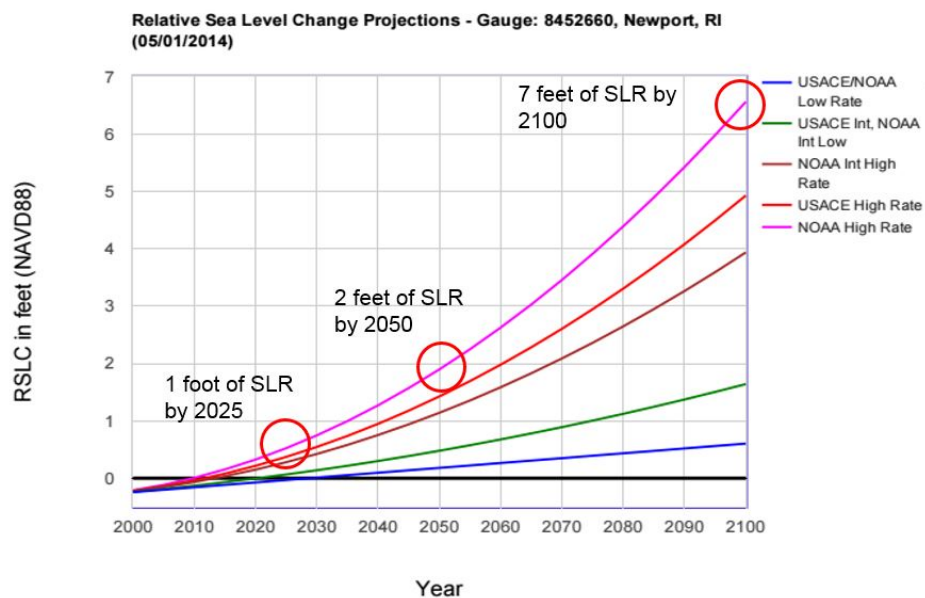
Figure 4. Sea level change projections for the southern coast of Rhode Island [3]. USACE, US Army Corps of Engineers; NOAA, National Oceanic and Atmospheric Administration.

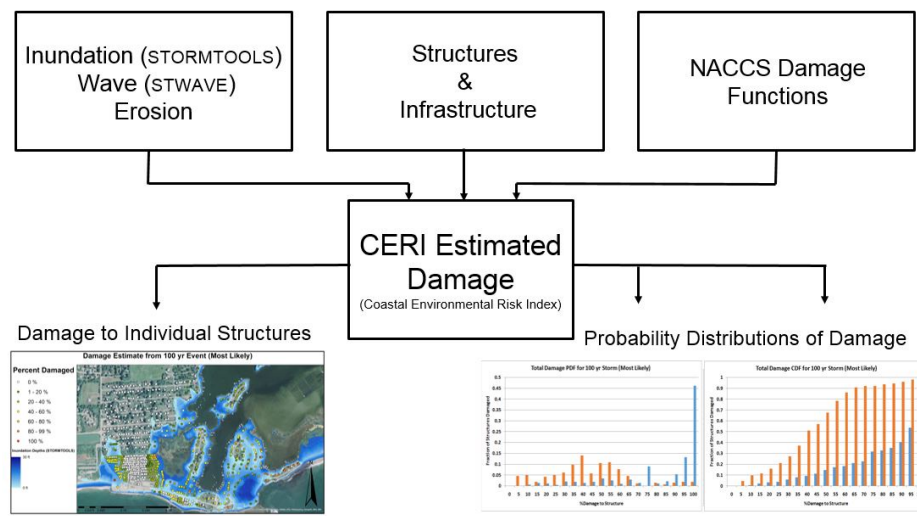
Figure 5. Flow chart showing the methodology used to estimate damage from storm surge and sea level rise in this study (See [3]). CERI, Coastal Environmental Risk Index; NACCS, North Atlantic Coast Comprehensive Study.

Figure 5 shows a flow chart of the organization of CERI. Inputs into CERI include detailed information about the structures within the study area, topography and bathymetry, and levels of inundation, wave heights, and erosion for different storm events. The level of damage for each structure was estimated using damage functions developed by the U.S. Army Corps of Engineers as part of the North Atlantic Coast Comprehensive Study (NACCS) [5]. The results were presented in

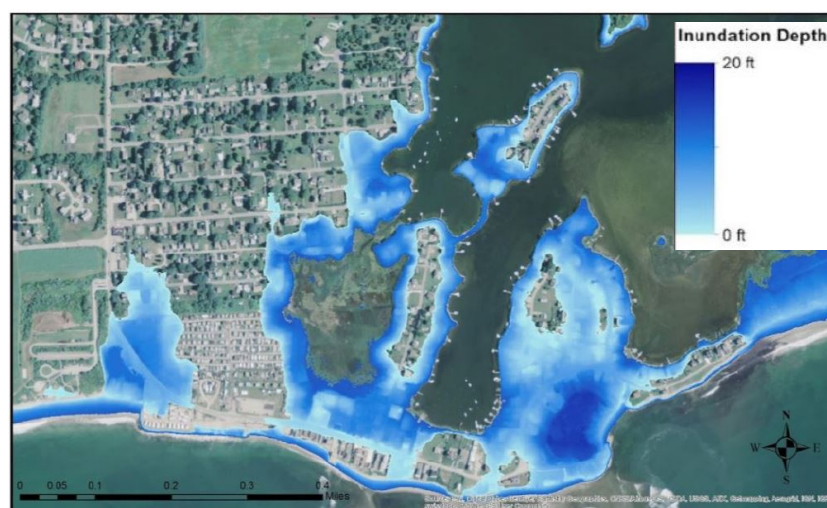
Figure 9. Extent of inundation within the study area from a 100-year storm event using the online tool STORMTOOLS [9].

Levels of inundation were estimated using an on-line tool developed for Rhode Island called STORMTOOLS [4,8]. Water levels for events of various return periods were obtained from NOAA’s gauge station in Newport, RI. The values were scaled based on storm models from the NACCS study [9] to obtain levels of inundation for 25, 50, and 100 year storm events that included 1, 3 and 7 feet of sea level rise, respectively. The NACCS water levels were derived from their surge plus tide (96 random tides) simulation case at the upper 95% confidence limit. This confidence interval was selected to account for uncertainties in the analysis. The results also included wave induced set up since the simulations were based on a fully coupled surge-wave model system. Values of inundation within the study area were provided on a 1 m grid, and Figure 9 shows the estimated inundation of the study area from a 100-year storm event [10].

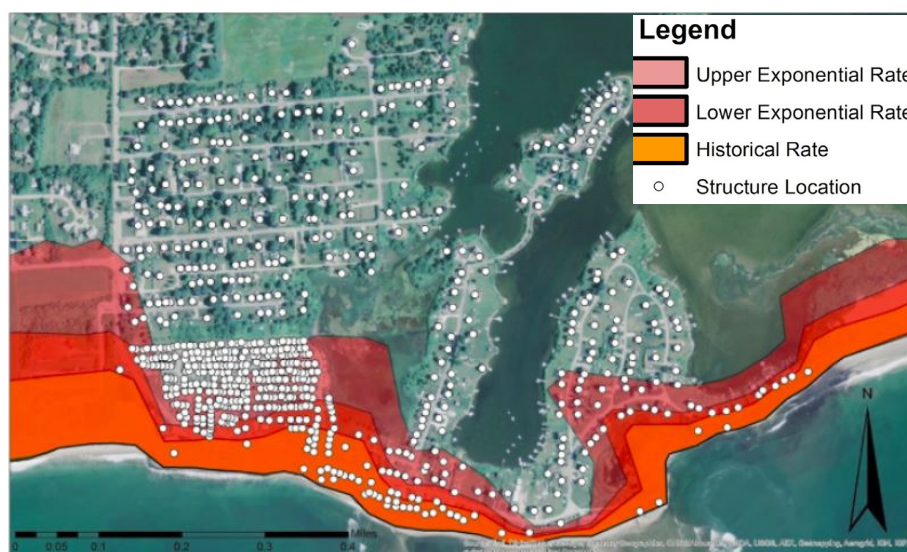
Figure 10. Estimated positions of the shoreline in the study area after 100 years using the historical erosion rate and two exponentially increasing erosion rates.

Erosion within the study area was estimated using shoreline change maps as shown in Figure 2. Based on the historical position of the shoreline from 1938 to 2014 [1], future erosion rates were projected using the historical rates and also two exponentially increasing erosion rates (an upper and lower estimate) that account qualitatively for the effects of increasing sea level rise. Figure 10 shows estimates of the shoreline position within the study area in 100 years. The projected shoreline erosion would clearly impact a number of structures, ranging from 59 for the historical rates up to 349 using the more conservative exponentially increasing rate.

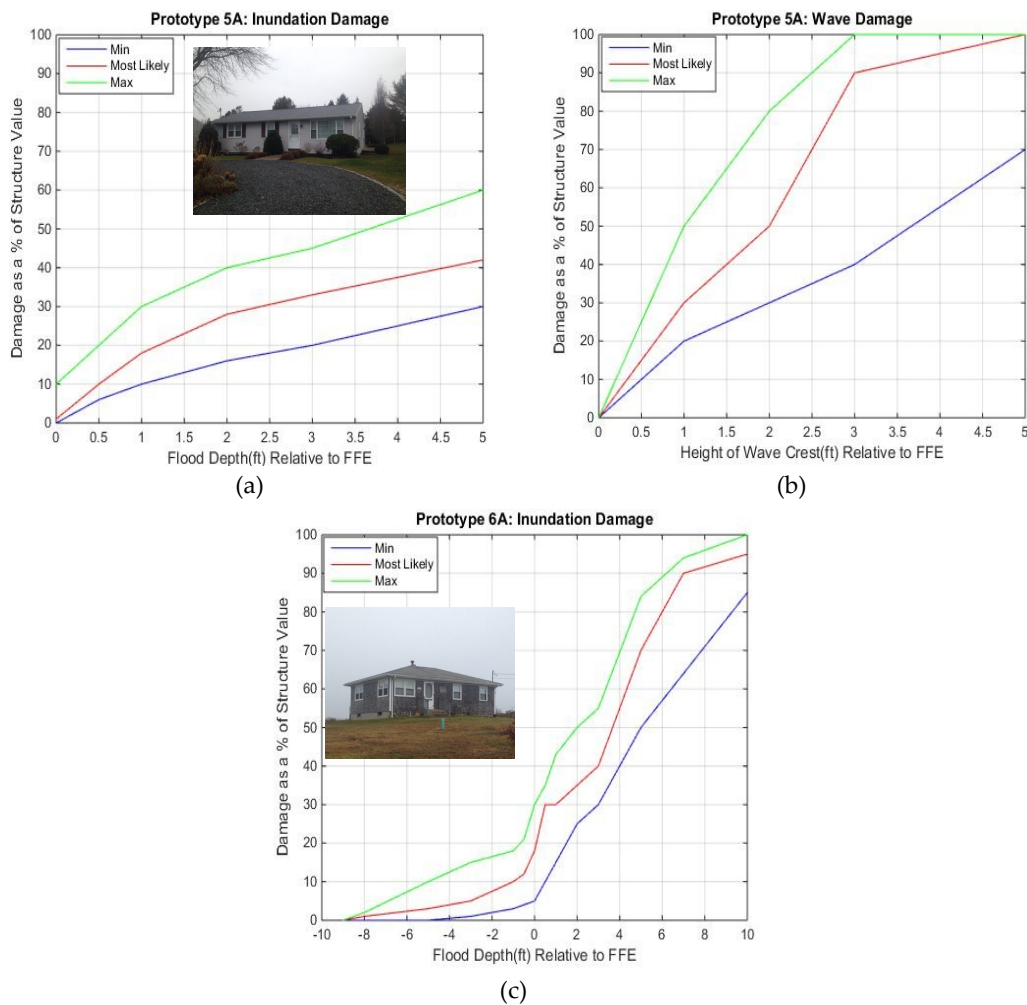
Figure 11. Examples of damage functions proposed by the NACCS: (a) inundation damage to single story residences with no basement (prototype 5A); (b) wave damage to single story residences with no basement (5A); and (c) inundation damage to single story residences with a basement (6A). Inset photographs show 5A and 6A structures within the study area.

Figure 11 shows examples of damage functions from the NACCS. Figure 11a,b show the relationship between the percent damage and elevation from inundation and wave attack for a single story residence with no basement (prototype 5A). The flood depth relative to FFE is used in the inundation damage function and the controlling wave crest height relative to FFE is used for the wave damage function. Figure 11c shows the inundation damage function for a single story structure with a basement (prototype 6A). This function reflects the damage that can occur from inundation of basements even if the flood depth is below the FFE.

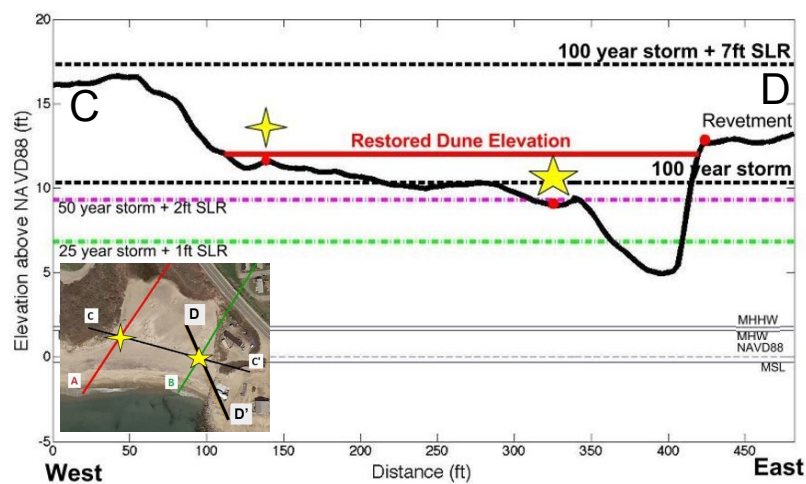
Figure 18. Cross section of southwest corner of the study area where a reinforced dune is proposed to mitigate damage from a 100 year storm event.

One potential solution would be to design and build a reinforced dune with a core of geotextile sand containers (GSC), such as the recently completed Montauk Stabilization Project in Long Island, New York [11]. Potential advantages of using reinforced dunes included the added stability over dunes without GSCs (particularly during the first five years while dune grass plantings are maturing) and reduced costs and permitting restrictions relative to hardened structures. Additionally, “soft” solutions such as reinforced dunes are typically designed for events with lower return periods than 100 years (e.g., 25 or 50 years), and as such they can provide a cost-effective solution that gives decision makers more time to assess the actual impacts of sea level rise on coastal communities.

It is estimated that construction of a reinforced dune at this location would protect 81 structures (Table 2) and would also protect the coastal road and evacuation route from storm surge and wave action up to a 100 year event (without sea level rise).
