Using Advanced Technologies to Assess Deterioration in Concrete Bridge Decks

A DISSERTATION SUBMITTED IN PARTIAL FULFILLMENT OF THE
REQUIREMENTS FOR THE DEGREE OF
DOCTOR OF PHILOSOPHY
IN
CIVIL AND ENVIRONMENTAL ENGINEERING

UNIVERSITY OF RHODE ISLAND

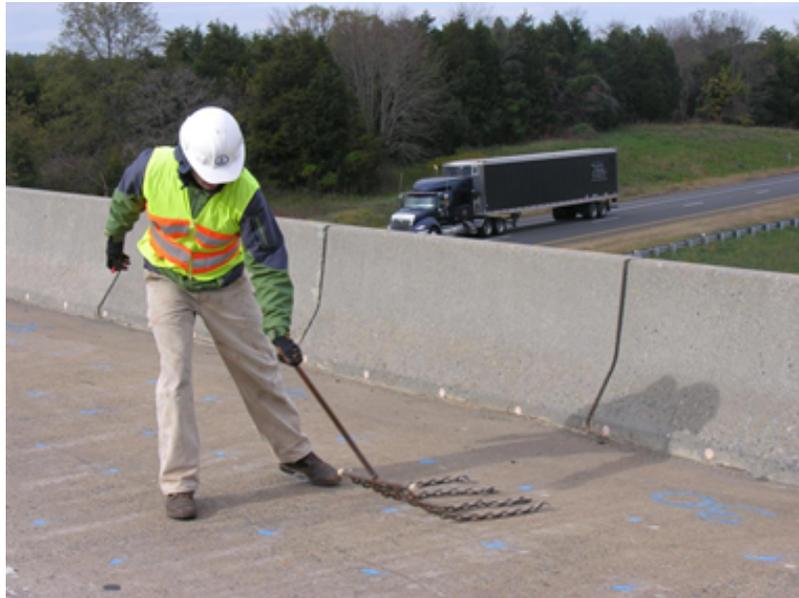
Chain dragging is a quick method of testing used for determining the general location of moderately to severely delaminated areas of a concrete bridge deck. The speed of the chain drag varies with the level of deterioration of the deck, and the experience of the operator.

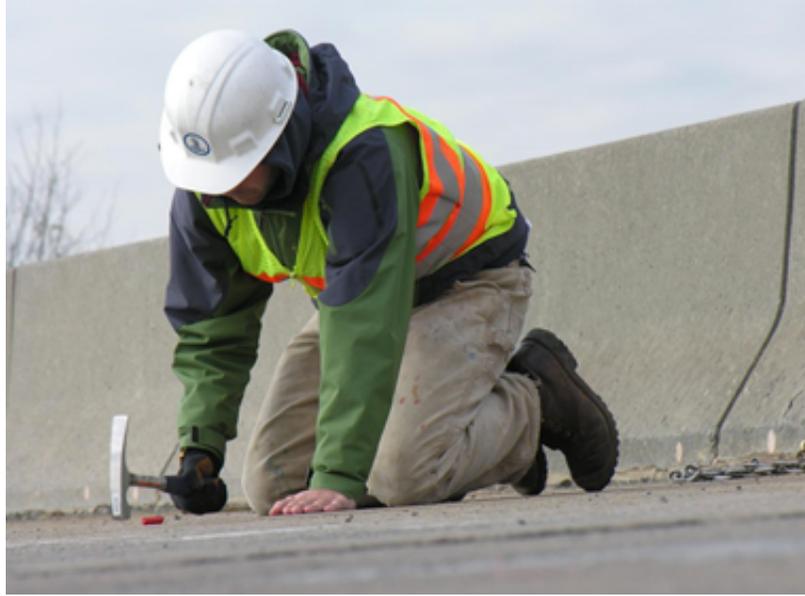
Hammer sounding is a slower method of testing, more appropriate for smaller areas. Hammer sounding can be used in conjunction with chain dragging in order to better define the size and extent of deterioration.

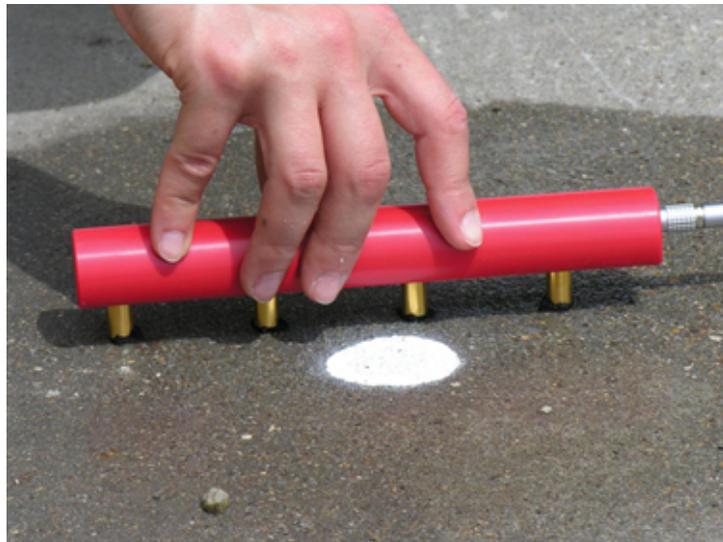
Figure 2.2.2: ER Testing

The resistivity is then calculated. Areas with low resistivity are indicative of corrosion, whereas areas with high resistivity are free from corrosion ^[13]. The X and Y coordinates of the test section can be plotted against the electrical resistivity measurements to create a corrosion map.

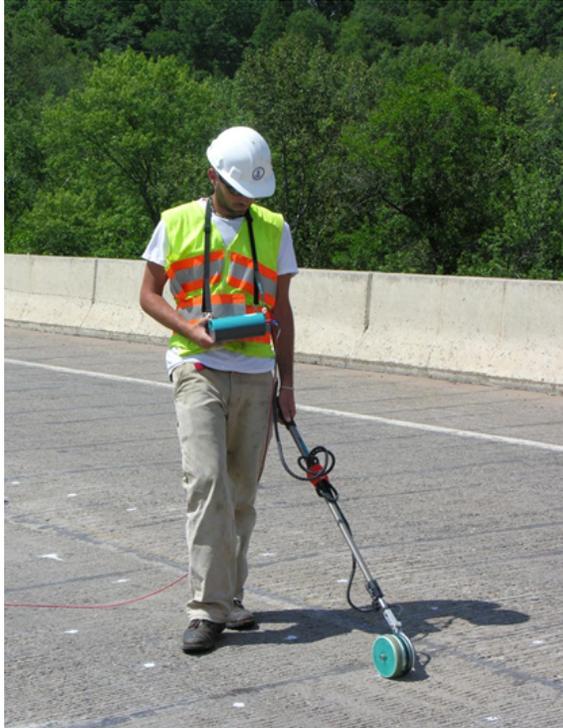
Figure 2.2.5: HCP Testing Using a Rolling Probe

Once HCP data are collected, X and Y coordinates can be plotted against measured voltage to produce a map showing areas of very high likelihood for active corrosion, very low likelihood for active corrosion, or a transition zone that spans the measurements in between in accordance with American Society for Testing and Materials (ASTM) standards ^[16].

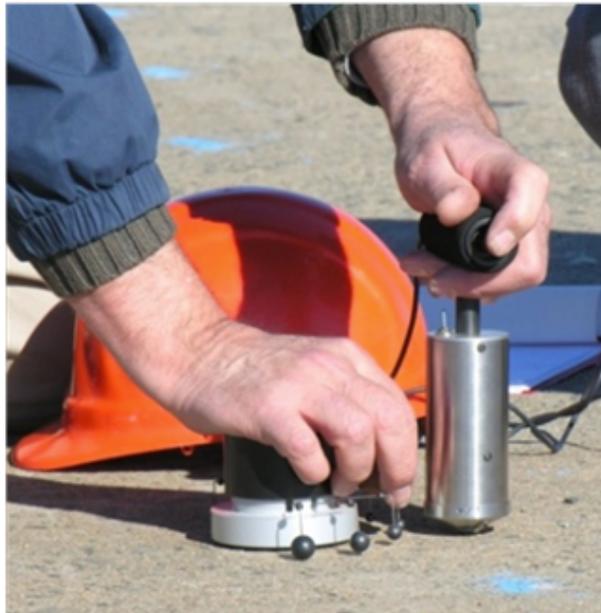
Figure 2.2.7: IE Testing Using Manual Probe

any areas with internal defects, will reflect waves with a difference in acoustic impedance. When reflected waves, or echoes, return to the surface, displacements are produced and the transient response time of the material is measured with the sensor. The amplitude spectrum obtained from the fast Fourier transform analysis of the time signal will show dominant peaks at certain frequencies, which can be interpreted to assess the deck condition [25].

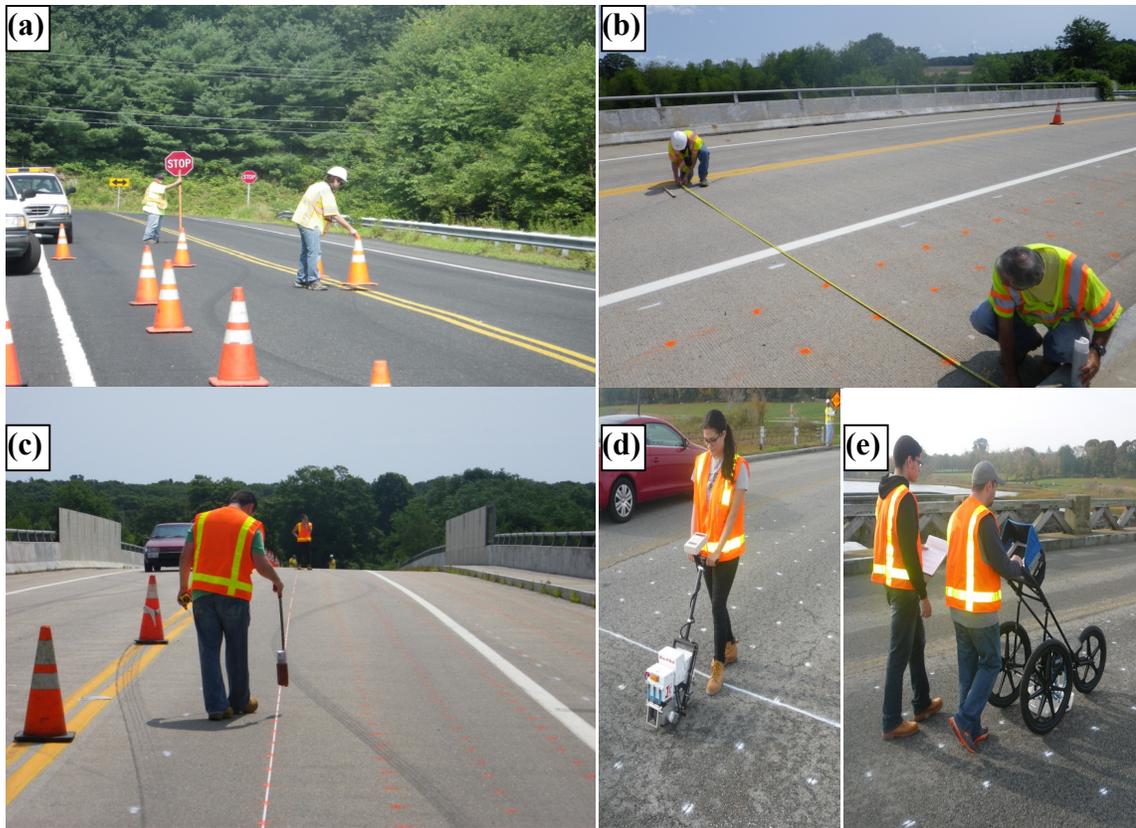
Figure 3.4.1: Field Testing Setup (a) Lane Closure and Traffic Control (b) Transverse Grid Markings (c) Longitudinal Grid Markings (d) Data Collection with the Surface Profiler (e) Data Collection with GPR

The first longitudinal line generally extended about 1 to 2 feet from the curb and each subsequent line was marked every foot until either the other curb was reached if testing the entire bridge deck, or near the center lane marking if testing only half of the bridge. Some distance was kept between the curb or center lane marking and the longitudinal line used for testing in order to avoid traffic traveling in an adjacent lane and to provide space for the equipment.

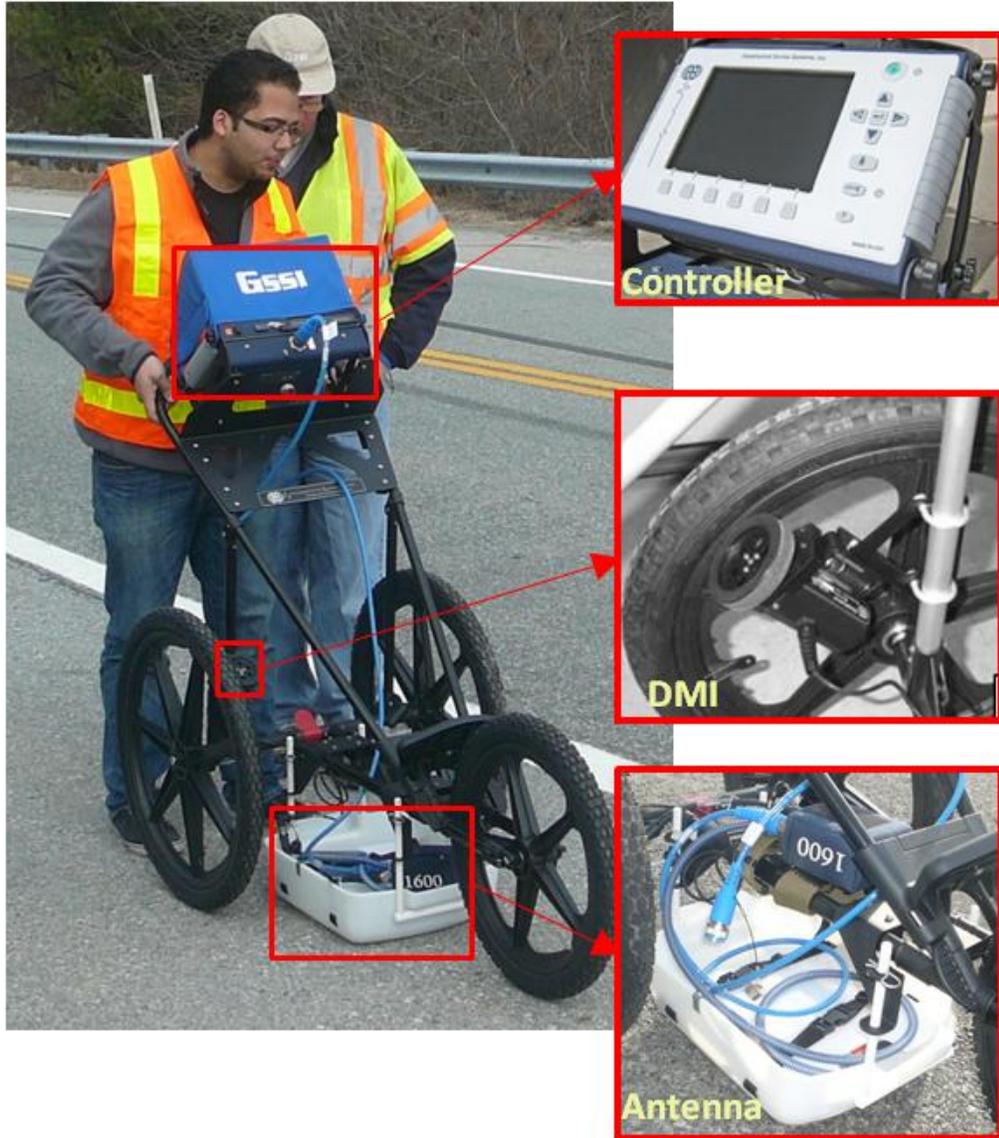
Figure 3.4.5: Components of the GSSI GPR Equipment

The GPR system used in this research is from Geophysical Survey Systems, Inc. (GSSI) and has three main components as shown in Figure 3.4.5. The SIR-3000 controller is a portable, single-channel GPR system with a display screen that allows data to be viewed in real time or in playback mode. The controller, shown in Figure 3.4.6, is connected to a distance measuring instrument (DMI) installed on the wheel and a 1.6 GHz center frequency ground-coupled antenna housed in a white bin that skims the roadway surface. All components are attached to a durable survey cart. Data are collected at a rate of 120 scans/ft (10 scans/in) over a range of 15 ns/scan.

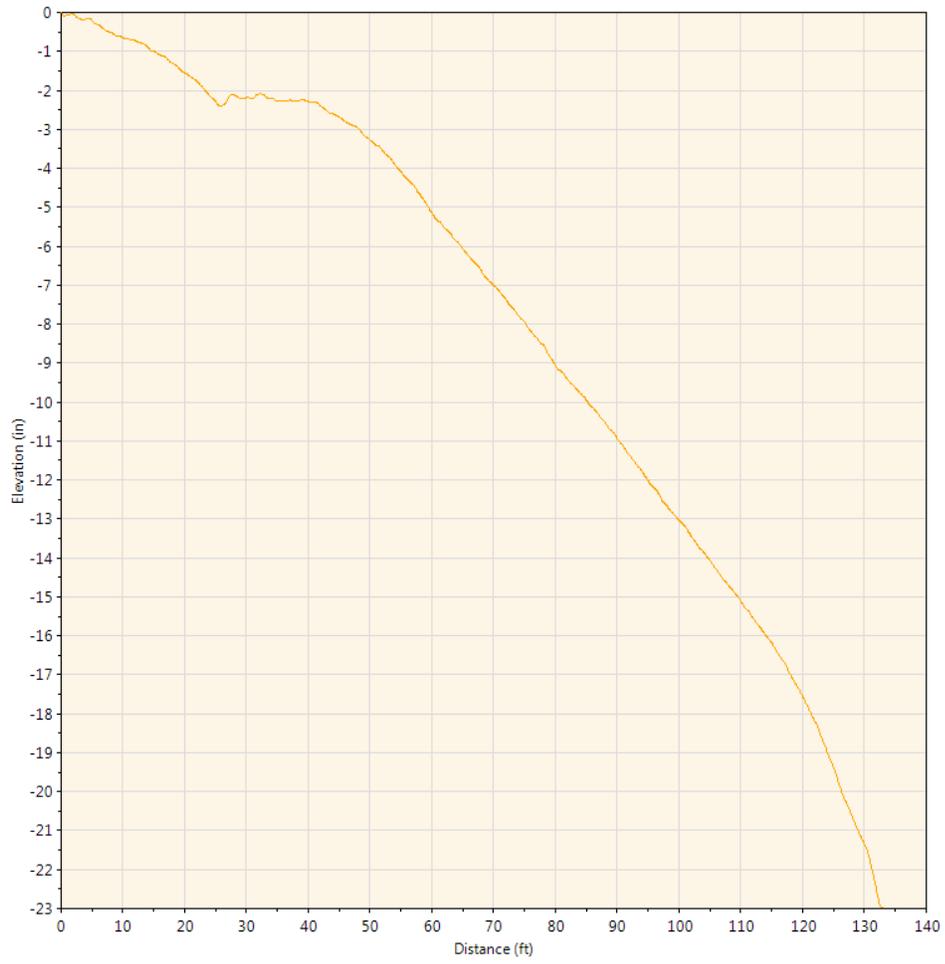
Figure 4.1.1: Raw Surface Profile from Ramp BB Bridge at 2 ft from Curb

rather the change in overall elevation of a measured road profile is displayed. Upon analyzing the sinusoidal curves, it can be noted that not all wavelengths are of great importance in regards to roughness measurement. In fact, many vehicle suspension systems are designed to remove or dampen the effect of many of the wavelengths in a profile. Wavelengths that are very long typically relate to vertical alignment and slope, and wavelengths that are very short typically relate to surface texture. The wavelengths that have the greatest influence on user comfort are those between 1 and 30 meters. When a road profile is processed to compute roughness, the wavelengths outside of this critical range, as well as the grade of the road are typically filtered out ^[24]. A filtered profile is shown in Figure 4.1.2.

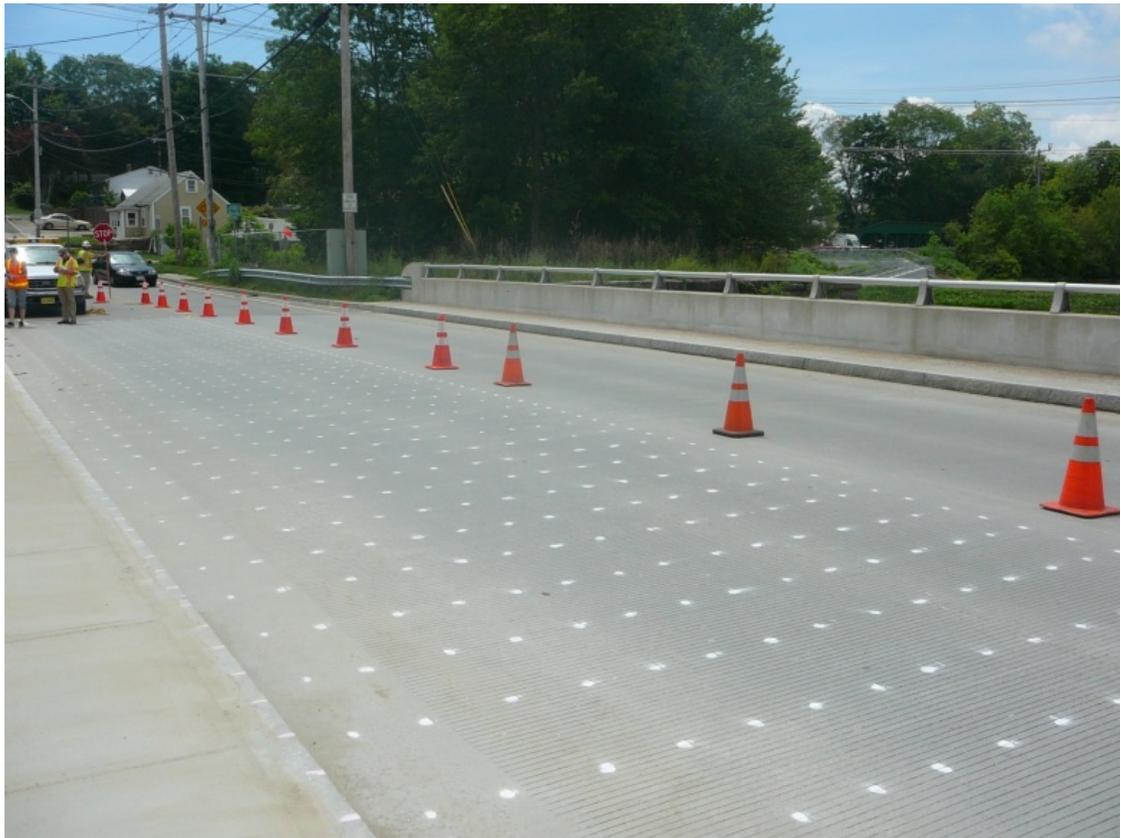
Figure 4.1.4: Major Nathanael Greene Bridge (Top) Deck Surface (Bottom) Surface Roughness Map

It is important to note the elevation deviation scale on each of the surface roughness maps at first, as the scale is not universal for the three candidate bridges. In keeping the elevation deviation scale unique to each bridge deck, areas red in color will always represent the highest elevations, and areas blue in color will always represent the lowest elevations. Therefore the most deteriorated areas, specific to each bridge deck, can be identified. Though areas of deterioration, the elevation deviation scale must be referenced, because deterioration can describe anywhere from 0.17 to 1.19 inches or -0.2 to -2.36 inches in this particular study.

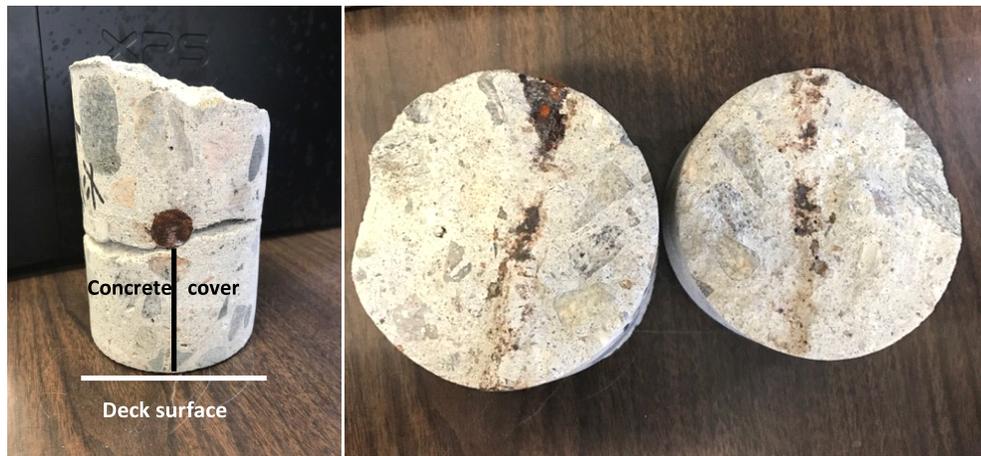
Figure 4.2.2: Potowomut Bridge Core 1 (X = 7 ft, Y = 25 ft)

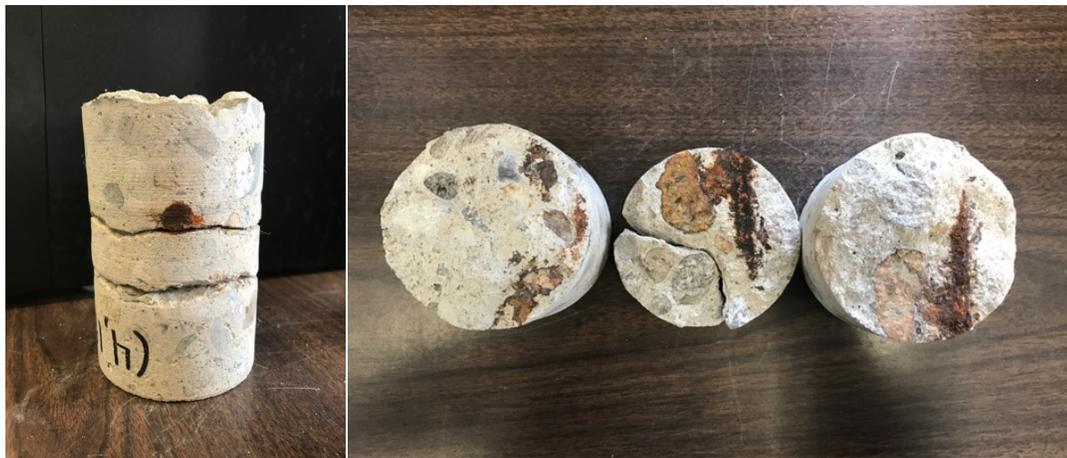
Figure 4.2.3: Potowomut Bridge Core 2 (X = 4 ft, Y = 15 ft)
