## Performance-based Assessment of Bridge Preservation

Sebastian Boy

A MASTER THESIS SUBMITTED IN PARTIAL FULFILLMENT OF THE

CIVIL ENGINEERING

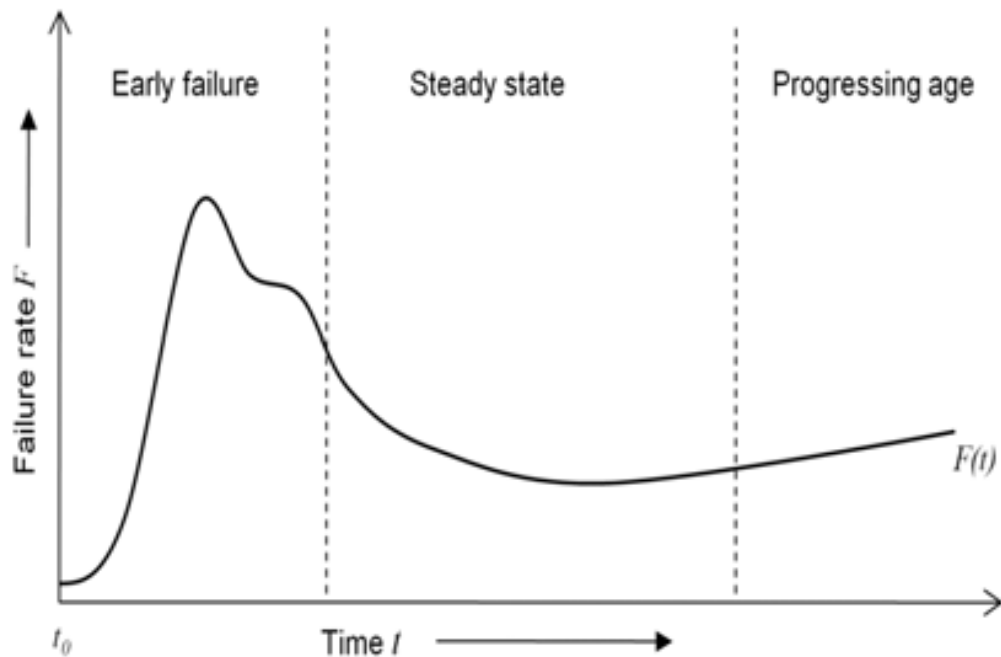
Figure 1: Typical failure rate of items (Naqib Daneshjo and Natália Jergová 2014)

A bridge is designed to meet certain design criterias. With time a bridge deteriorates and the bridge can collapse due to different failures. At the beginning of a bridge's life-cycle is a high error rate due to failures in the production process, such as quality deficits in building materials or human mistakes. The failure rate decreases after early failures and increases with the bridge's getting older and deteriorating, as Figure 1 shows (Naqib Daneshjo and Natália Jergová 2014).

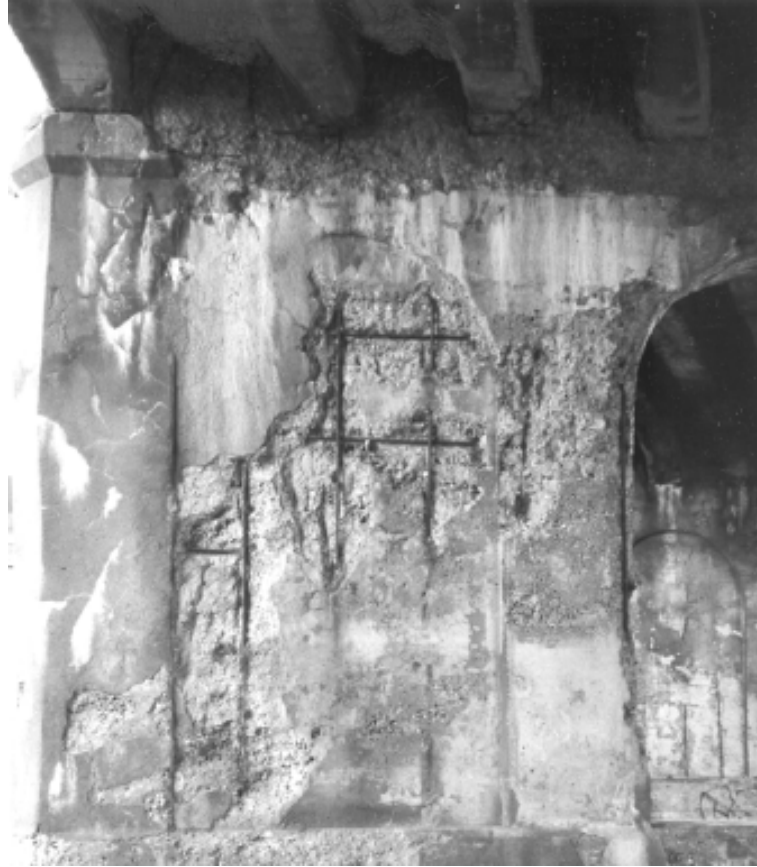
Picture 2: Severe spalling at bridge pier (Gaal 2004)

If chloride ions migrate into concrete through diffusion and physical defects in the concrete, the corroding rebar forms voluminous corrosion products (Lee, Seung-Kyoung 2012b p. 2). The corrosion process involving chlorides is different because the dissolved iron atoms not only react with hydroxyl ions, but also with iron to form iron chloride ( $\text{FeCl}_2$ ). If the highly soluble iron chloride comes in contact with water, for example in corrosion pits, it reacts partially with water to form hydrochloric acid and iron hydroxide. The hydrochloric acid leads to a drop of the pH-value which accelerates the dissolution of iron (Gaal 2004). The stress arising from the corrosion of the reinforcement on the surrounding concrete then leads to cracking, delamination, and spalling of concrete, as shown in Picture 2.

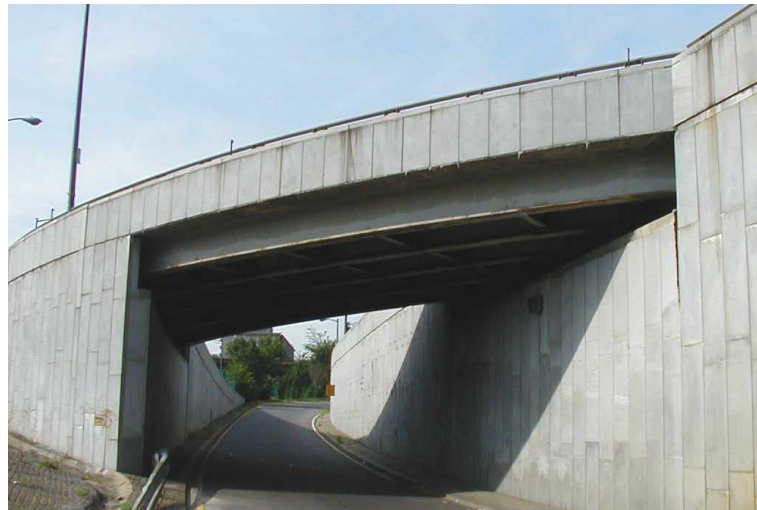
Picture 3: Rolled Beams (Ryan, Thomas W. et al. 2012)

girders. Wire ropes, parallel wires, or seven wire strands are called cables. These are used for suspension and cable-stay bridges. The difference between these bridges is that the cables on a suspension bridge are running from anchors on the earth on each side of the bridge over the towers and the bridge is suspended by secondary vertical cables from the upper cable to the bridge surface. The cables on a cable-stayed bridge are attached to the pole and the bridge surface, which are then supporting the horizontal bridge. Steel plates are used to construct built-up shapes, whereas steel bars are placed in concrete to provide reinforcement or used as secondary tension members in truss and arch bridges. Rolled shapes are made by rolling a block of steel either hot or cold. The typical shape, the “I” shape, is mainly used as structural beam and column (Picture 3) (Ryan, Thomas W. et al. 2012).

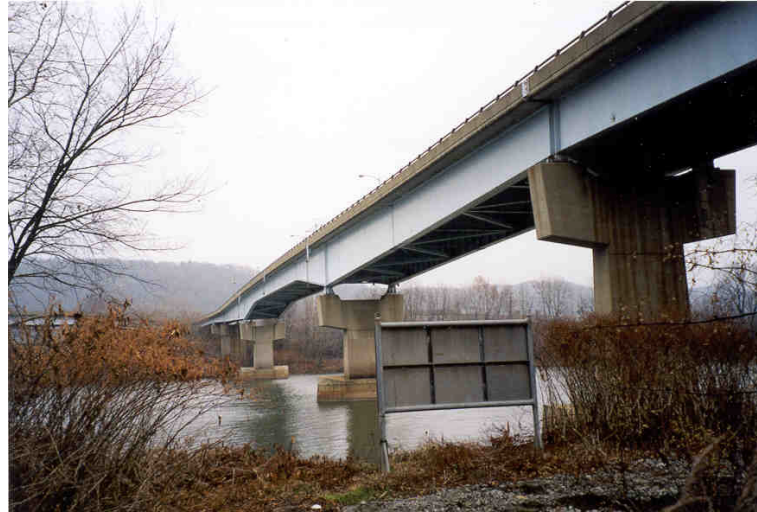
Picture 4: Built-up girder (Ryan, Thomas W. et al. 2012)

different shape is required which cannot be made with a rolled shape, for example I-girders (Picture 4), box girders, and truss members (Ryan, Thomas W. et al. 2012).

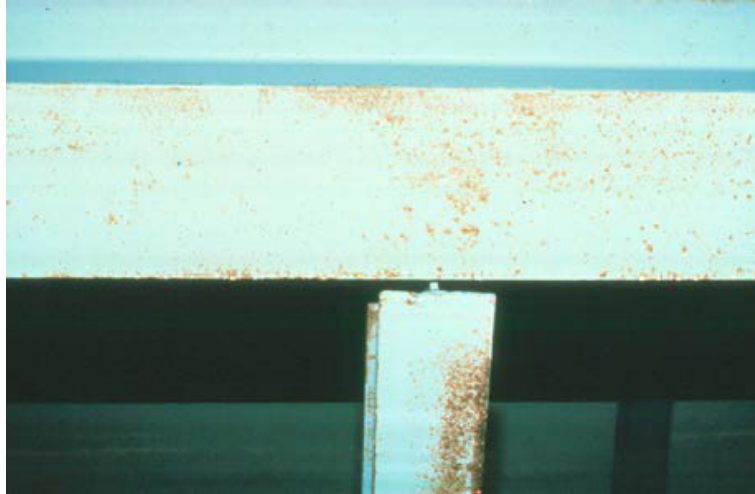
Picture 5: Pinpoint rusting at pinholes (Ryan, Thomas W. et al. 2012)

The most common coating failures also include applying too much paint, painting over surface contaminants, pinholes (tiny, deep holes in the paint, as shown in Picture 5), undercutting (mostly at sharp edges or scratches, as shown in Picture 6), bleeding (soluble color pigments from the undercoat penetrate the topcoat) and more (Ryan, Thomas W. et al. 2012).

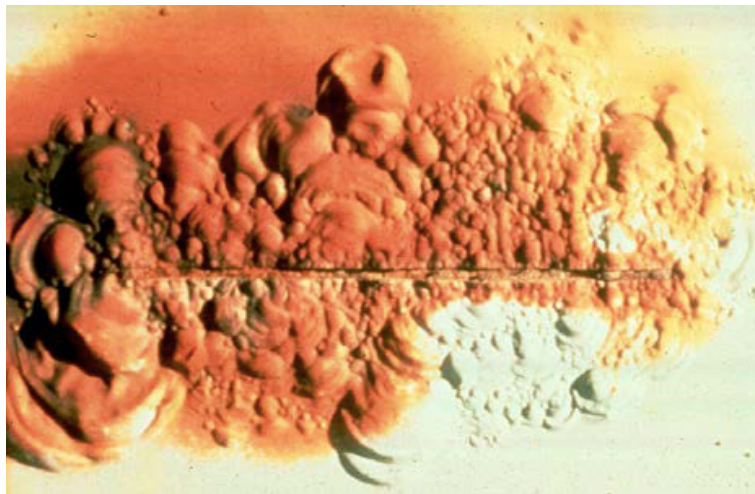
Picture 6: Rust undercutting at scratched area (Ryan, Thomas W. et al. 2012)

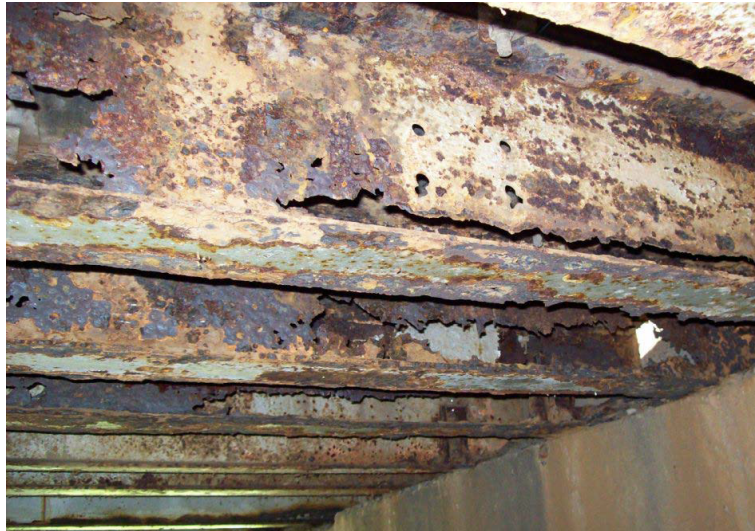
Picture 7: Steel corrosion and complete section loss on girder webs (Ryan, Thomas W. et al. 2012)

Corrosion is accelerated by deicing chemicals and is the primary cause of section loss in steel members and occurs as described in Chapter 2.1.1 and shown in Picture 7 (Ryan, Thomas W. et al. 2012).

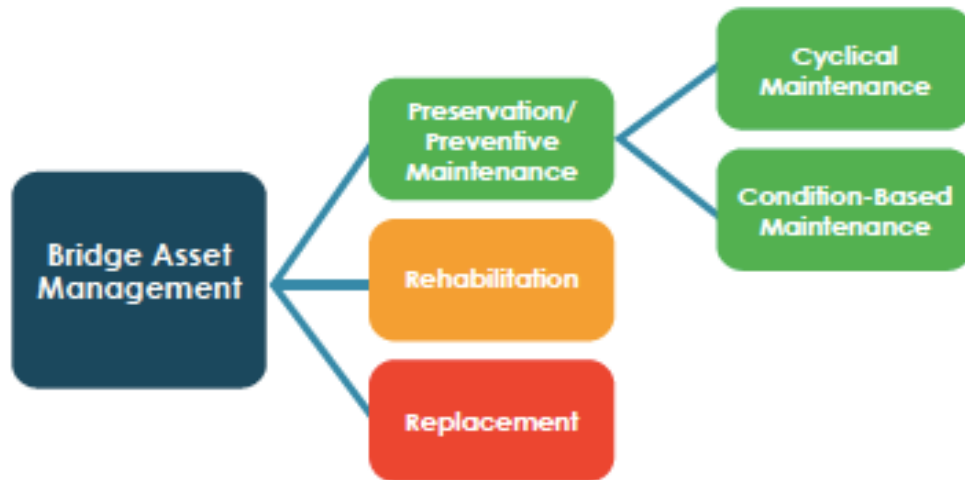
Figure 5: Bridge action categories (FHWA 2018d)

This chapter, therefore, gives an overview on asset management (Chapter 3.1) as basis for bridge management and preservation. For clear terminology the term maintenance (Chapter 3.2) and different kinds of maintenance are briefly defined thereafter, before preservation/preventive maintenance (Chapter 3.2.5), rehabilitation (Chapter 3.3), and replacement (Chapter 3.4) are described as part of asset management, as Figure 5 shows.

As the word maintenance indicates, it is to maintain the condition of a bridge or transportation system and to restore the transportation system into a functional state of operation (FHWA 2017c). The DIN EN 13306:2018-02, as a European standard which serves as a guideline, describes maintenance as a “combination of all technical, administrative and managerial actions during the life-cycle of an item intended to retain it in, or restore it to, a state in which it can perform the required function” (DIN Deutsches Institut für Normung 2017). Bridge maintenance makes little or no change to bridge inventory data and includes cleaning, minor repair, major repair, component treatment, and component replacement (Hearn and Johnson 2011). Maintenance can be remote, on line, and on-site. Remote means that no direct physical access to the item is present, and on line means that maintenance is done during operating the item, whereas on-site means that the maintenance is done where the item is normally used or stored (DIN Deutsches Institut für Normung 2017). Also, maintenance is scheduled (cyclical in Figure 5) or reactive (condition-based in Figure 5) (Naqib Daneshjo and Natália Jergová 2014).

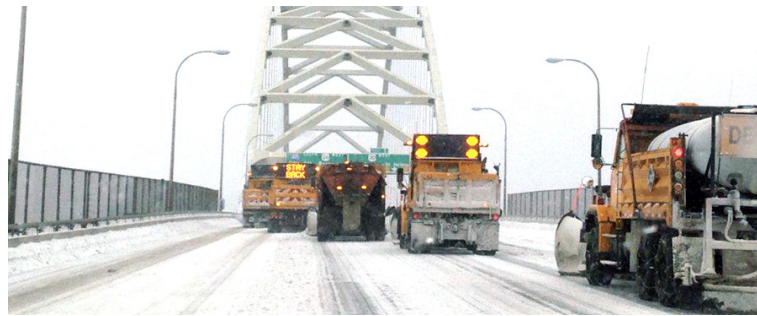
Picture 8: Bridge snow removal (FHWA 2018d)

Examples for routine maintenance are snowfall/application of deicing salt, trash/litter/dead animal removal, graffiti removal, accidents and storm damage, and asphalt patching.

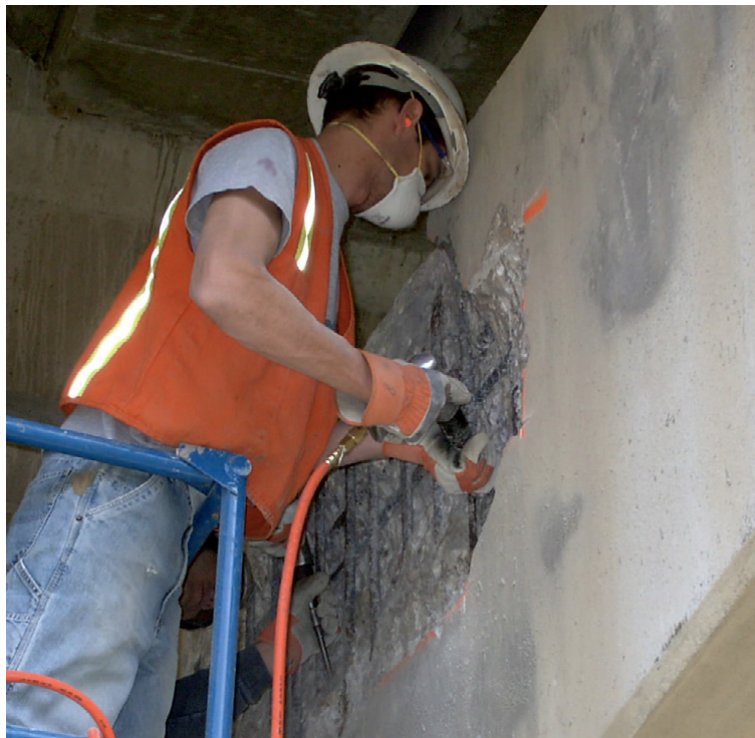
Picture 9: Substructure repair (FHWA 2018d)

Rehabilitation is done if the structural integrity of a bridge has to be restored. This requires major work such as partial or complete deck replacement, superstructure replacement, and substructure/culvert strengthening or partial/full replacement.

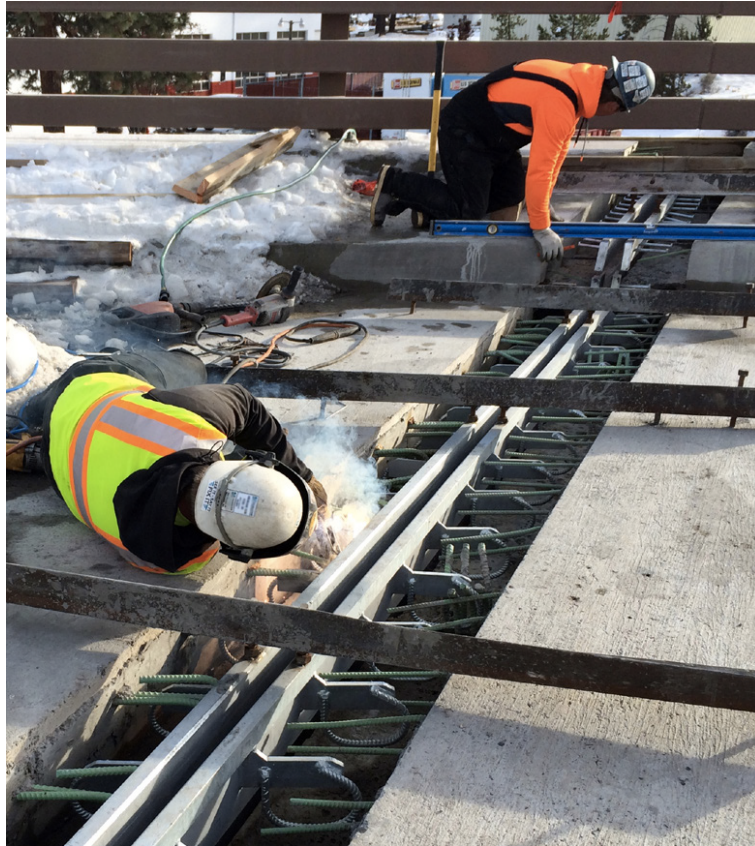
Picture 10: Joint replacement (FHWA 2018d)

Replacement is done if rehabilitation would not add enough value to the bridge and if the strategy is to replace a bridge instead of preserving it. Total replacement of a bridge needs engineering work to meet the current geometric, structural, and construction standards. Replacement of a bridge part, like joint replacement, is done if the rest of the bridge is still in a condition worth keeping (FHWA 2018d).

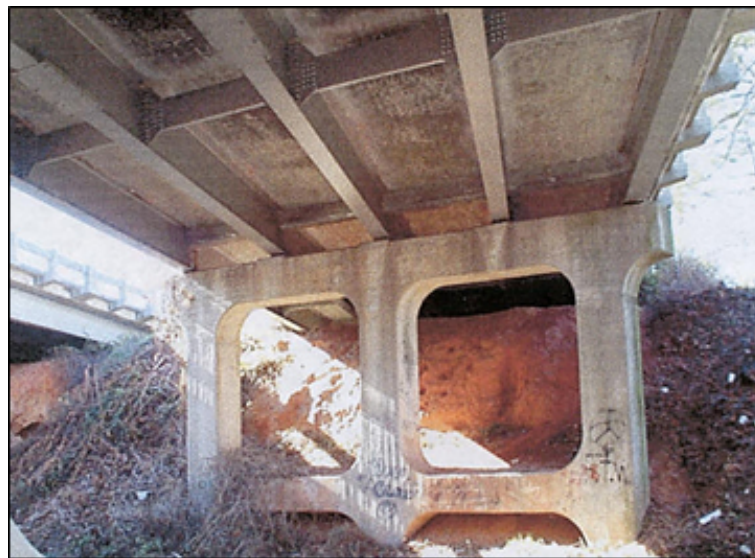
Picture 12: Steel stringer/multi-beam bridge – Davidson County Bridge 89 on the Lexington Bypass (NCDOT 2013)

According to the NBI database most of the bridges in Rhode Island are stringer/multi-beam (Picture 12) or girder bridges (54.92%), followed by box beam or girders (Multiple) bridges (11.40%) and arch-deck bridges (10.10%), as shown in Graph 9. In the United States most of the bridges are also stringer/multi-beam or
