ENHANCED VISUAL BRIDGE INSPECTION PRACTICES FOR AN IMPROVED BRIDGE MANAGEMENT SYSTEM

A THESIS SUBMITTED IN PARTIAL FULFILLMENT OF THE REQUIREMENTS
FOR THE DEGREE OF
MASTER OF SCIENCE
IN
CIVIL AND ENVIRONMENTAL ENGINEERING

UNIVERSITY OF RHODE ISLAND

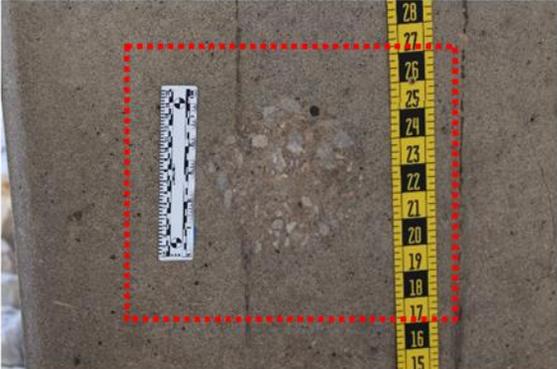
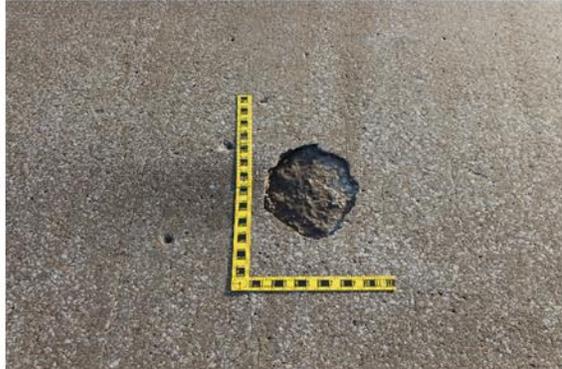
Condition State 2	Condition State 3
Delaminated. Spall 1 in. or less deep or 6 in. or less in diameter. Patched area that is sound.	Spall greater than 1 in. deep or greater than 6 in. Diameter. Patched area that is unsound or showing distress. Does not warrant structural review.

Figure 6: Visual Guide for Defect 1080 CS 2 and CS 3 (AASHTO, 2019)

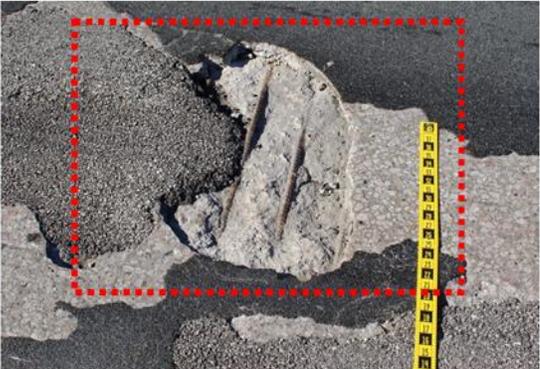
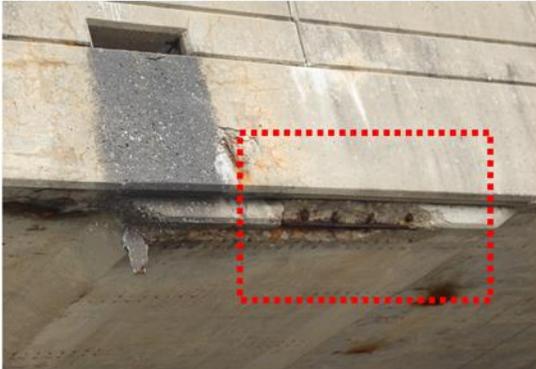
Condition State 2	Condition State 3
Present without measurable section loss.	Present with measurable section loss but does not warrant structural review.

Figure 7: Visual Guide for Defect 10390 CS 2 and CS 3 (AASHTO, 2019)

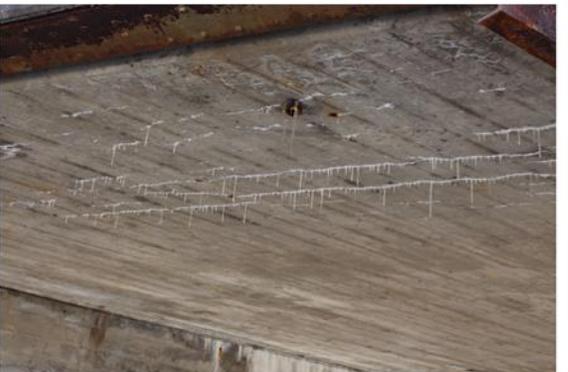
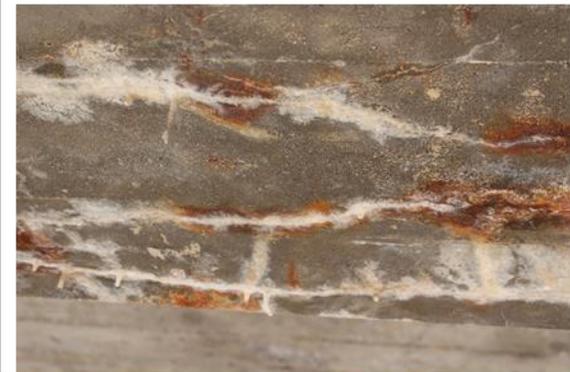
Condition State 2	Condition State 3
Surface white without built-up or leaching without rust staining.	Heavy built-up with rust staining.

Figure 8: Visual Guide for Defect 1120 CS 2 and CS 3 (AASHTO, 2019)

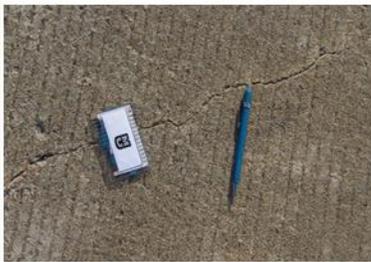
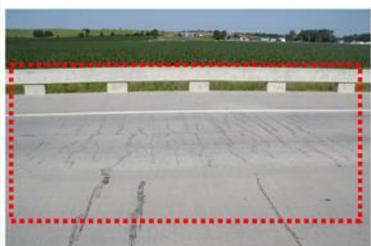
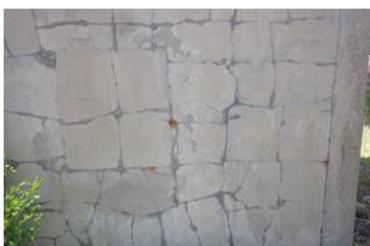
Condition State 1	Condition State 2	Condition State 3
Insignificant cracks or moderate-width cracks that have been sealed.	Unsealed moderate width cracks or unsealed moderate pattern (map) cracking.	Wide cracks or heavy pattern (map) cracking.
Width less than 0.012 in.	Width 0.012 – 0.05 in.	Width greater than 0.05 in.
Spacing greater than 3.0 ft.	Spacing of 1.0 – 3.0 ft.	Spacing of less than 1 ft.

Figure 9: Visual Guide for Defect 1130 CS 1, CS 2, and CS 3 (AASHTO, 2019)

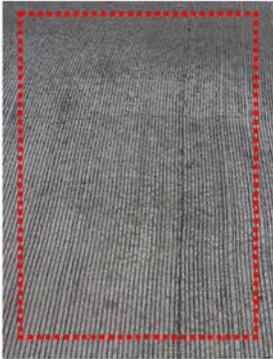
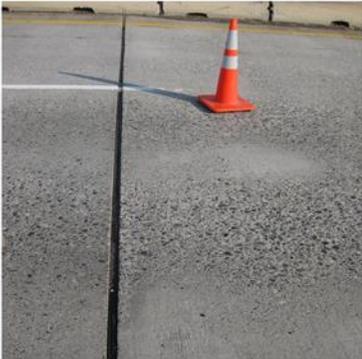
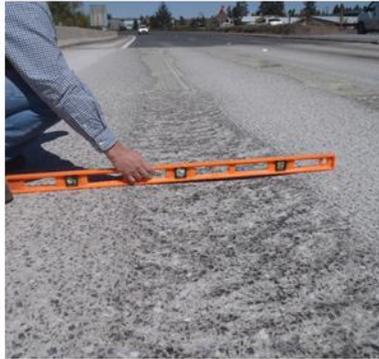
Condition State 1	Condition State 2	Condition State 3
No abrasion or wearing.	Abrasion or wearing has exposed coarse aggregate, but the aggregate remains secure in the concrete.	Coarse aggregate is loose or has popped out of the concrete matrix due to abrasion or wear

Figure 10: Visual Guide for Defect 1190 CS 1, CS 2, and CS 3 (AASHTO, 2019)

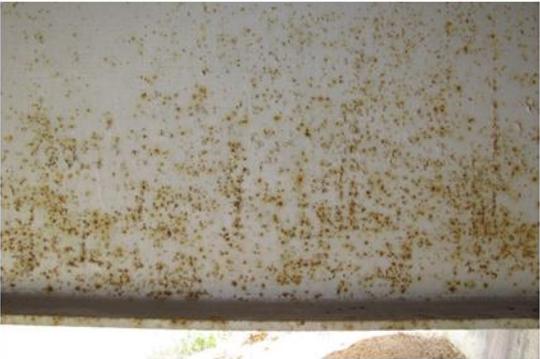
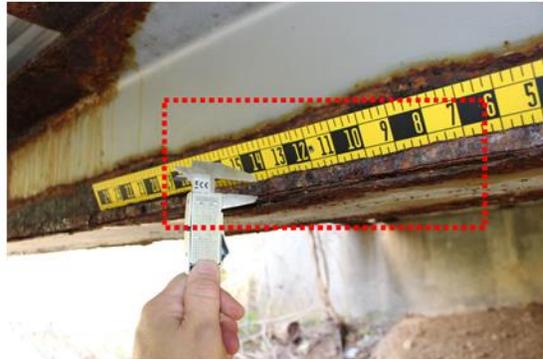
Condition State 2	Condition State 3
Freckled rust. Corrosion of steel has initiated.	Section loss is evident or pack rust is present but does not warrant structural review.

Figure 13: Visual Guide for Defect 1000 CS 2 and CS 3 (AASHTO, 2019)

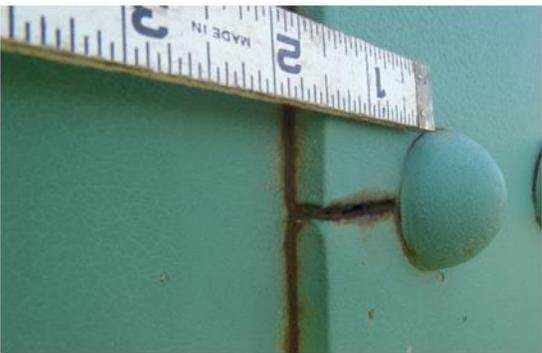
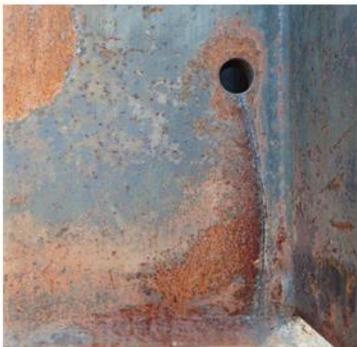
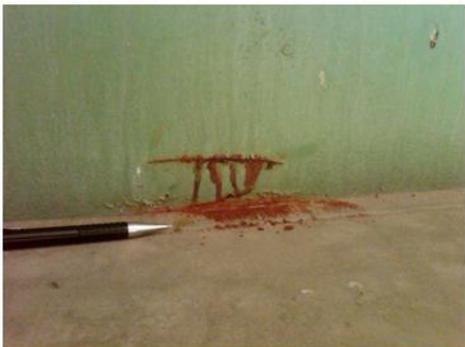
Condition State 2	Condition State 3
Crack that has self-arrested or has been arrested with effective arrest holes, doubling plates, or similar	Identified crack that is not arrested but does not warrant structural review.

Figure 14: Visual Guide for Defect 1010 CS 2 and CS 3 (AASHTO, 2019)

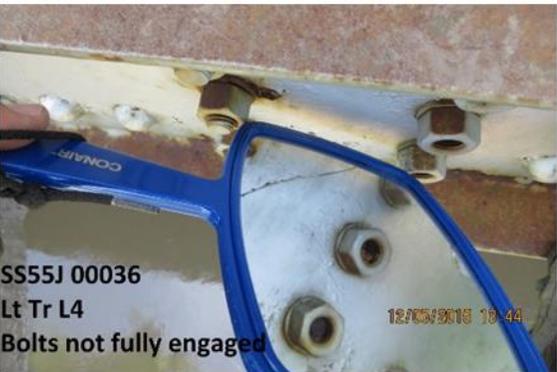
Condition State 2	Condition State 3
Loose fasteners or pack rust without distortion is present but the connection is in place and functioning as intended.	Missing bolts, rivets, or fasteners; broken welds; or pack rust with distortion but does not warrant structural review.

Figure 15: Visual Guide for Defect 1020 CS 2 and CS 3 (AASHTO, 2019)

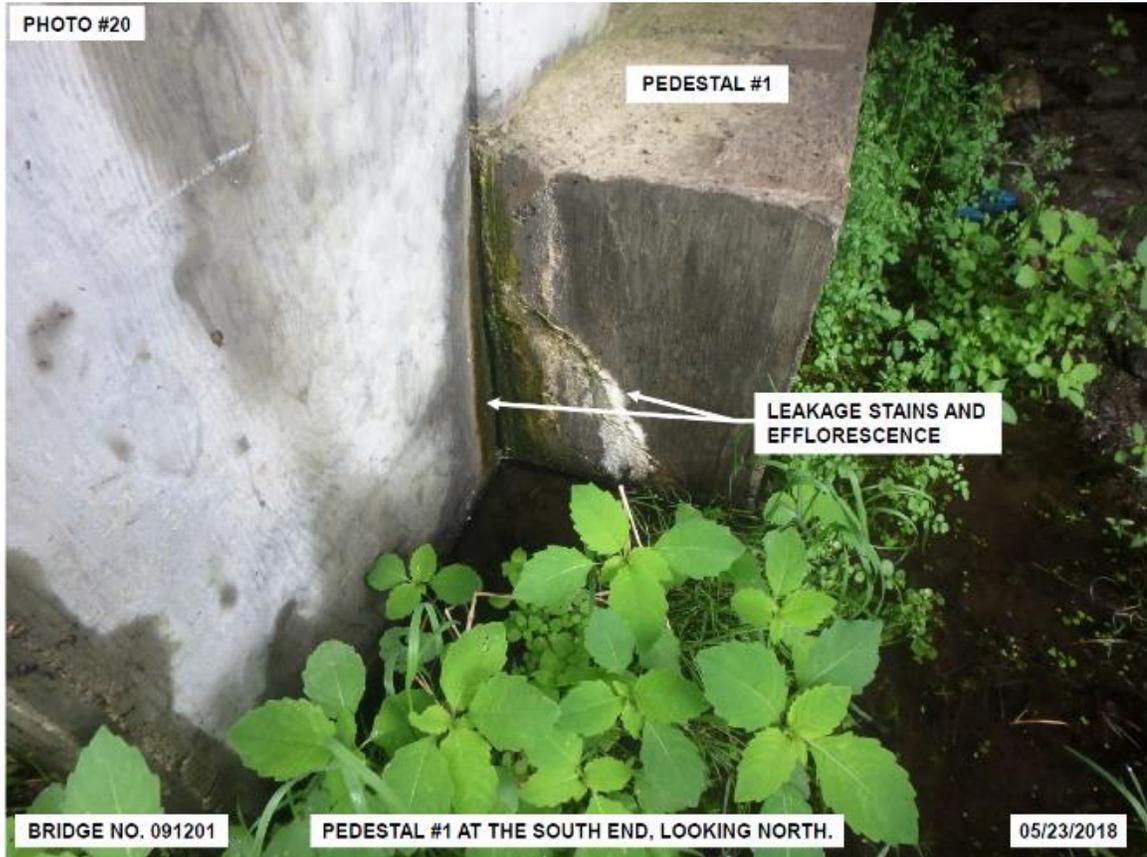
Figure 75: Arch IV Pedestal 1S, Conventional Inspection Report (RIDOT, 2018b)

Figure 74 shows the defect information assessed in 2018 and Figure 75 displays the photo documentary for this specific defect. The conventional inspection report does not provide any quantified information for this defect.

The reinforced concrete pedestals have several full height vertical hairline cracks with efflorescence, (See Photos 19 and 21). The south ends of both pedestals have leakage stains and efflorescence, (See Photos 20 and 23).

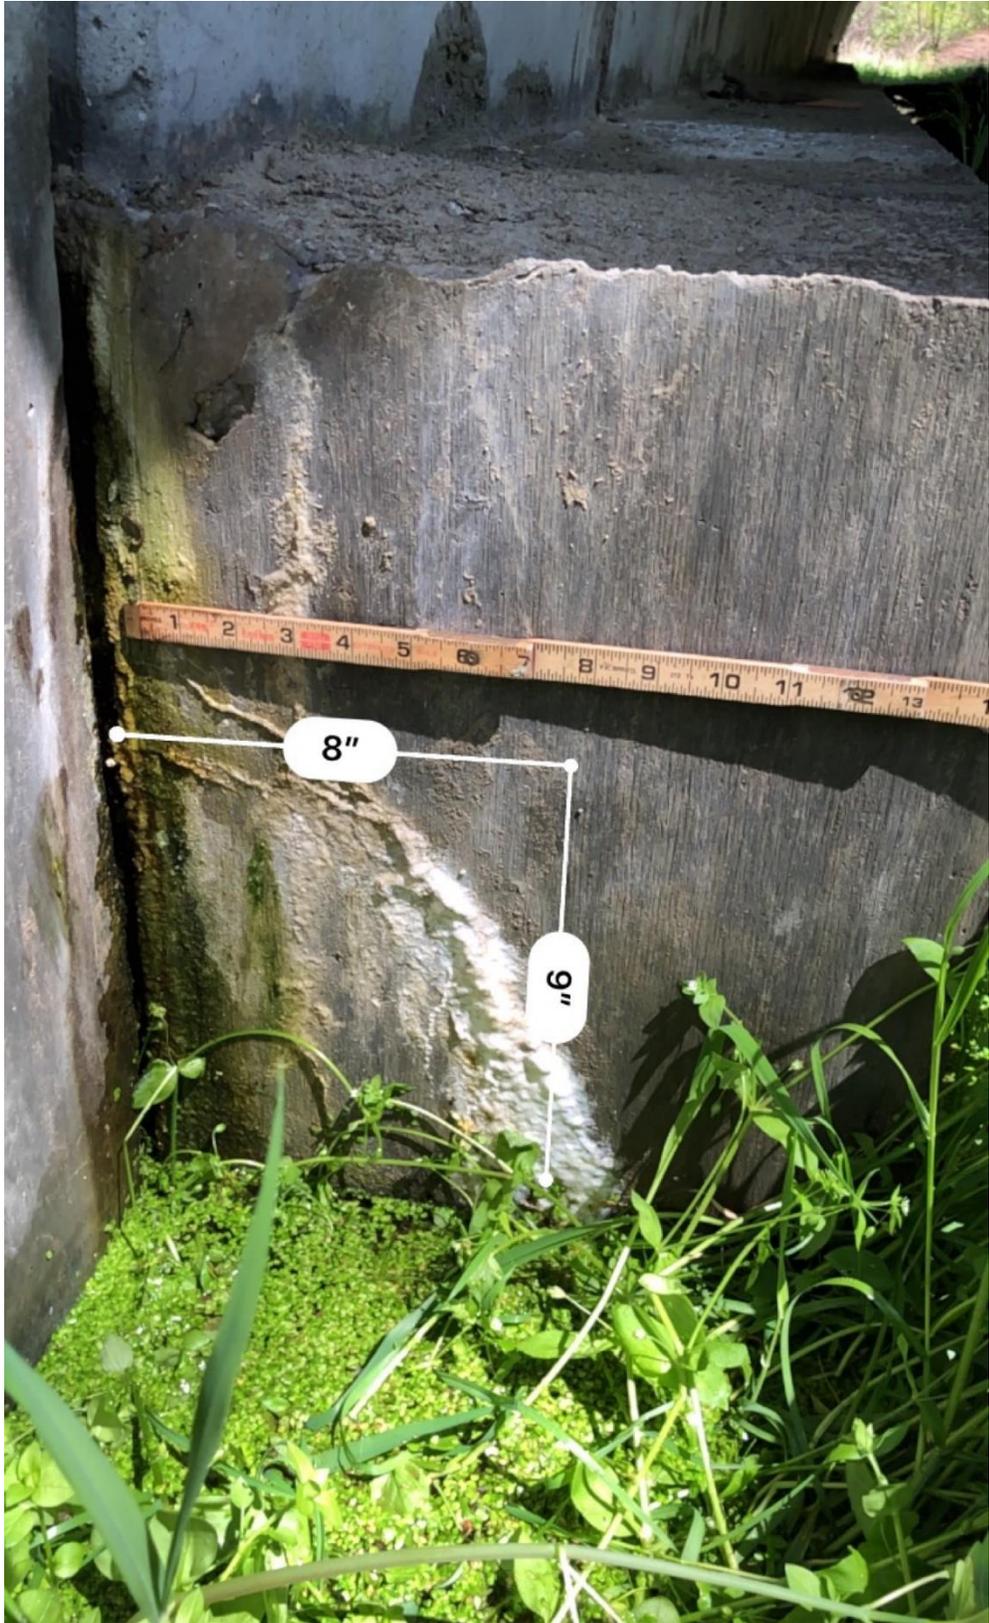
Figure 77: Arch IV Pedestal 1S, ID 2020 215-1120 Quantified Extent Width (own photo)

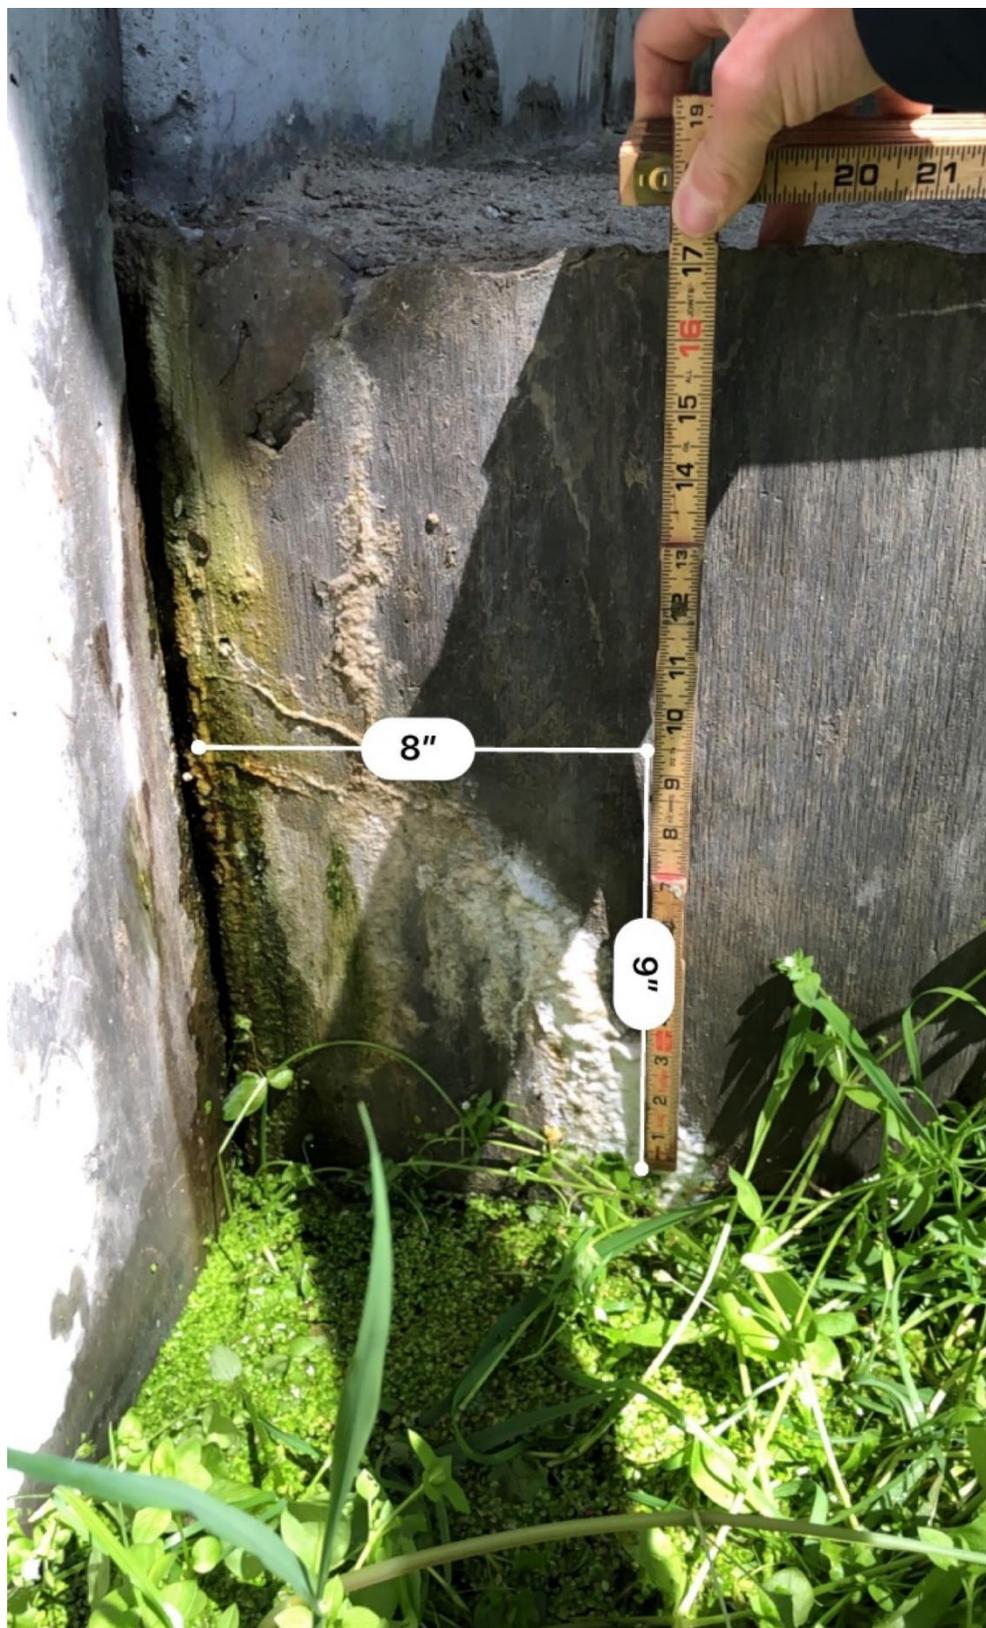
Figure 78: Arch IV Pedestal 1S, ID 2020 215-1120, Quantified Extent Height (own photo)

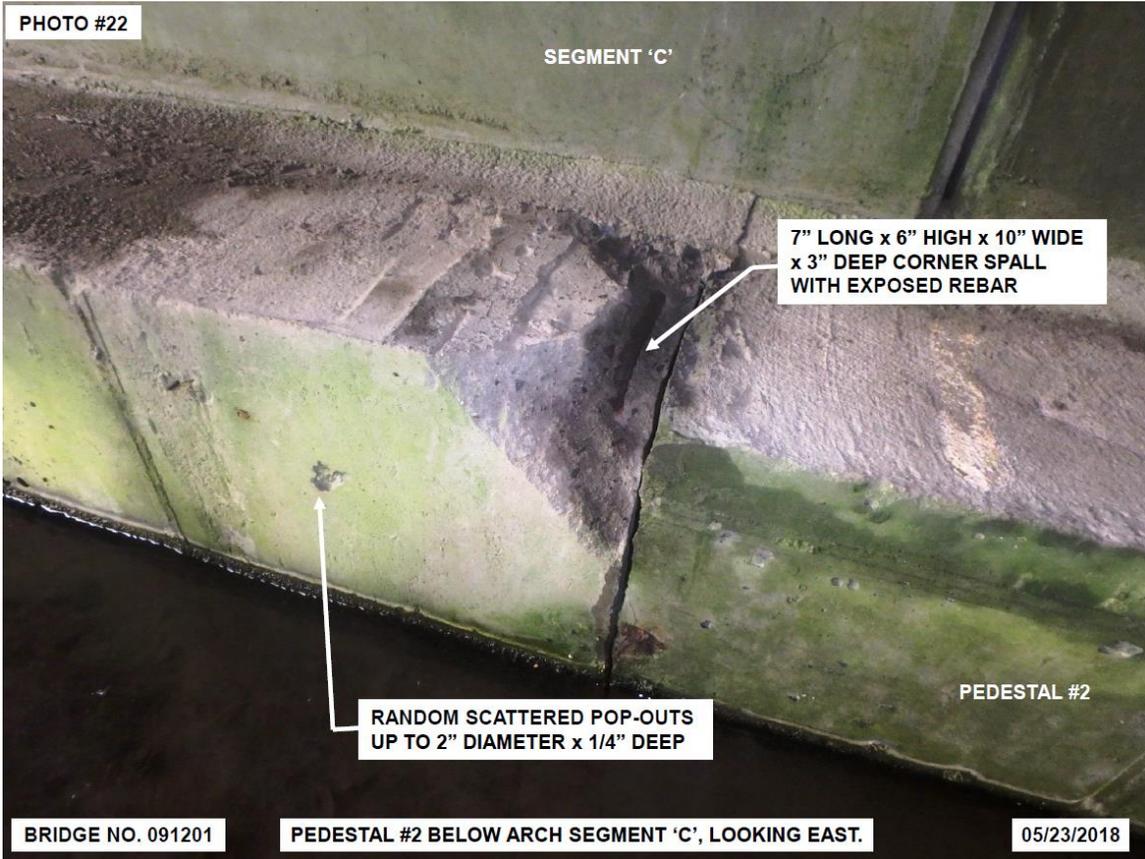
Figure 84: Arch IV Pedestal 2C, Conventional Inspection Report (RIDOT, 2018b)

Figure 83 shows the defect information assessed in the 2018 inspection report and Figure 84 displays the photo documentary for this specific defect. The defect is quantified by the inspector, but the measurement is not traceable. Therefore, review of this defect assessment is difficult.

Pedestal #2 below arch Segment 'C' has a 7" long x 6" high x 10" wide x 3" deep corner spall with exposed rebar, (See Photos 13 and 22).

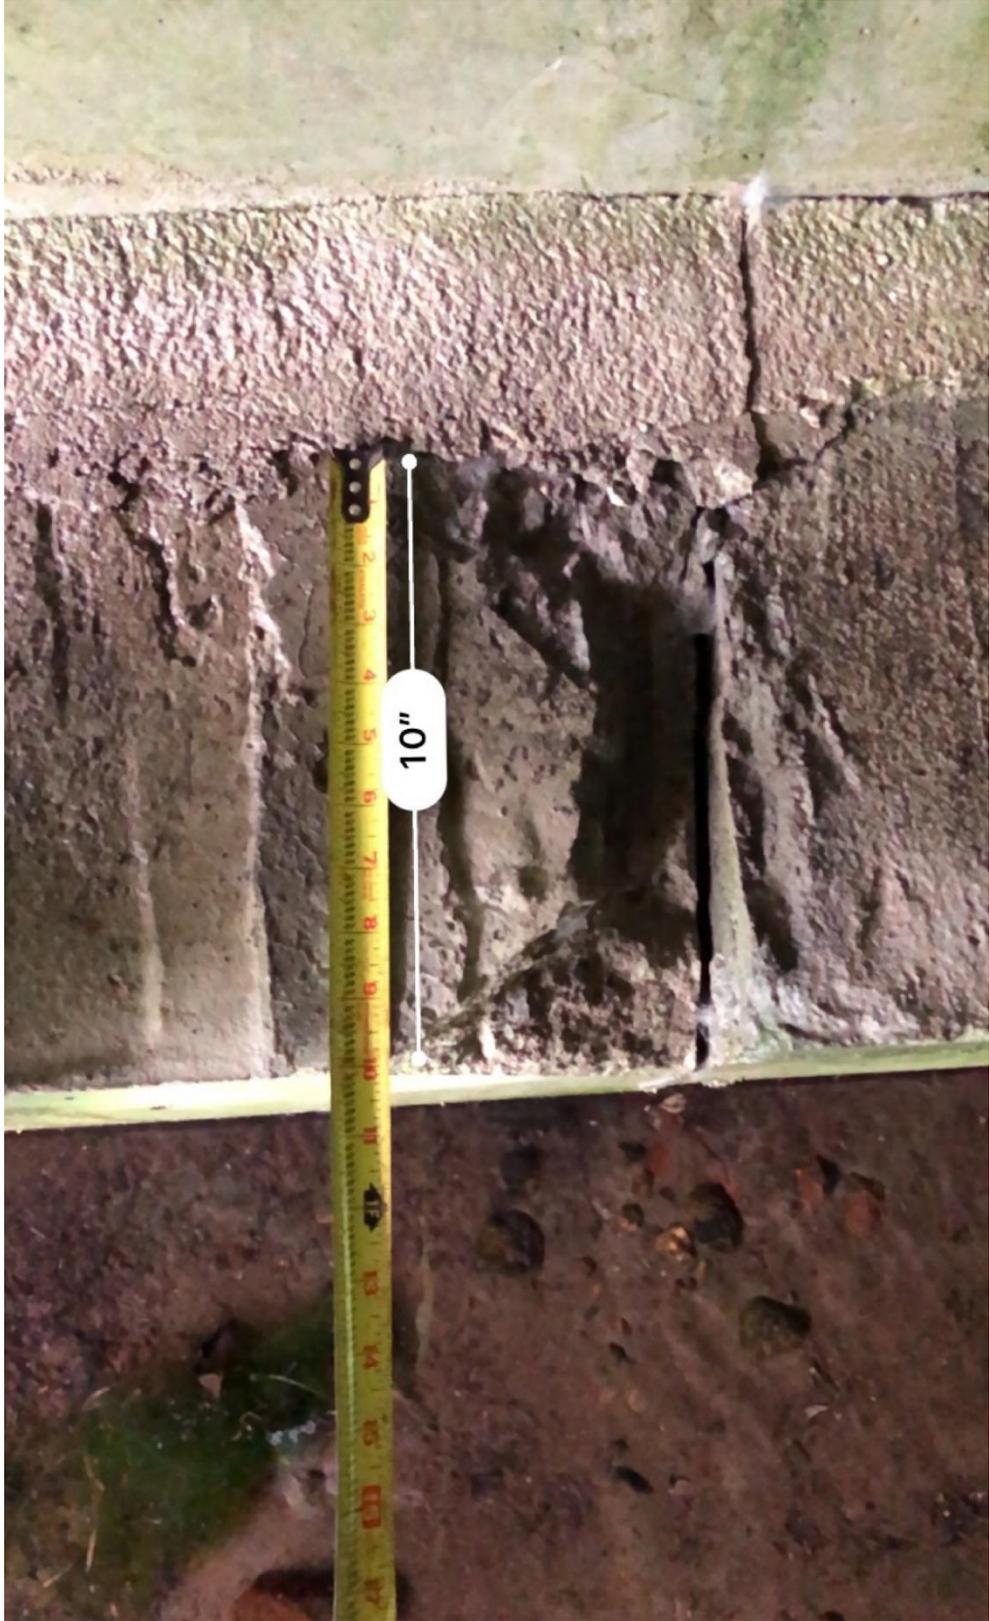
Figure 87: Arch IV Pedestal 2C, ID 2021 215-1080, Defect Width (own photo)

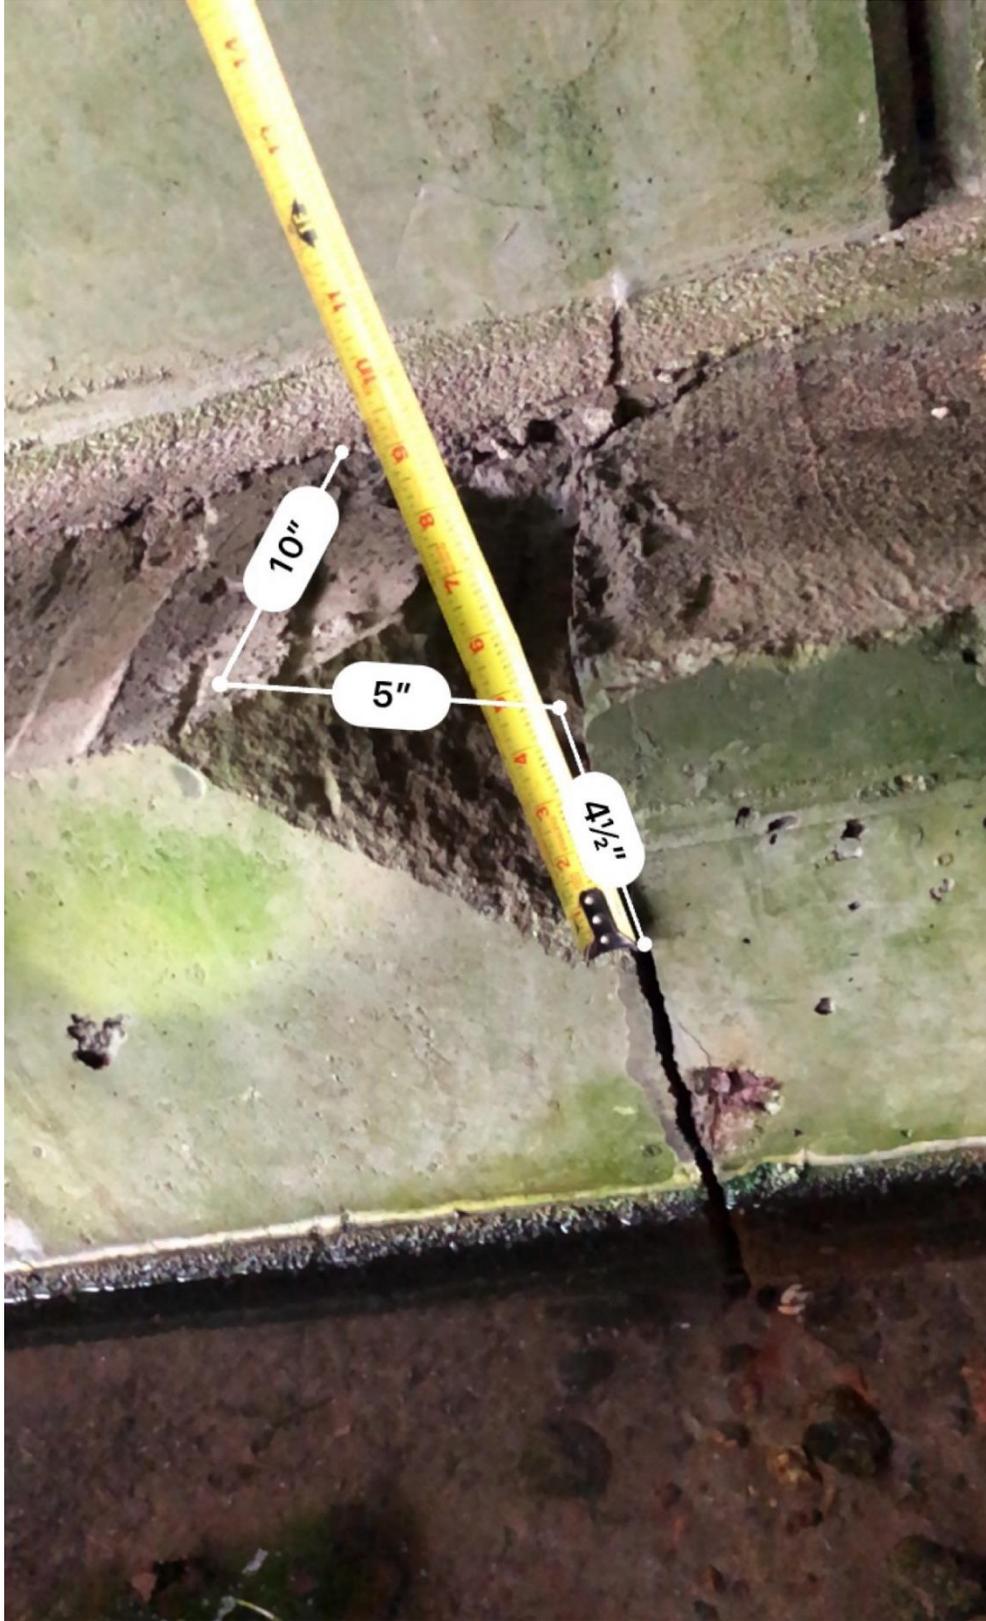
Figure 88: Arch IV Pedestal 2C, ID 2021 215-1090, Defect Height (own photo)

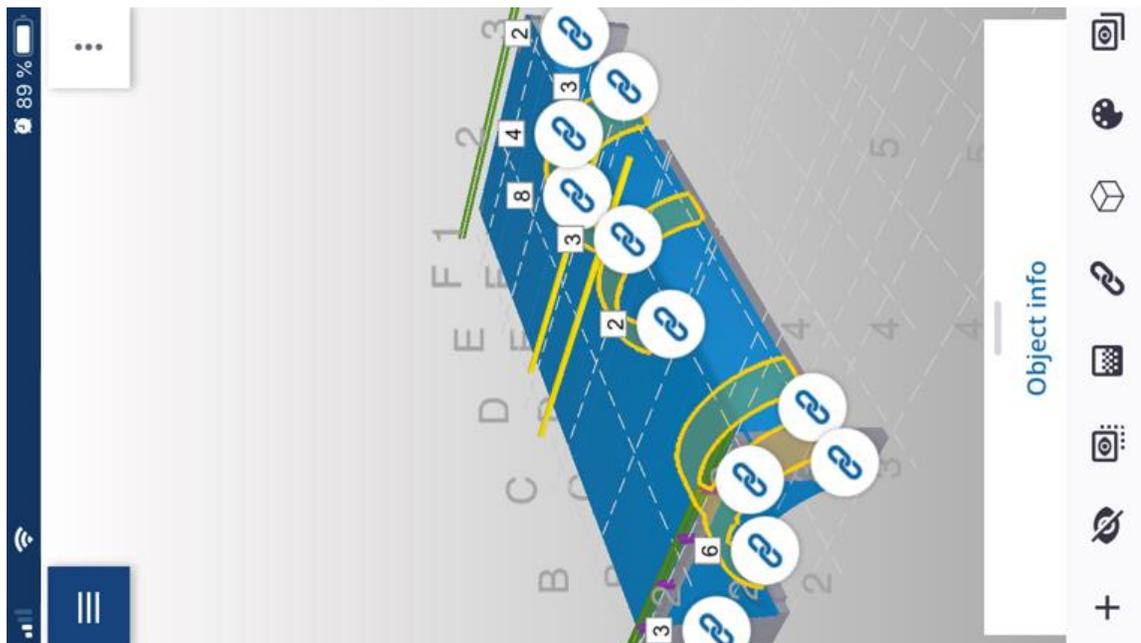
Reviewing previous inspections and the overall condition of the bridge is enhanced by these views. Conventional inspection reports do not provide comparable views of the defect distribution within the structure.

Figure 89: Trimble Connect Mobile Application, ID: 144-1080 Distribution (own figure)
